1. No flush C200S/CS

Before starting, check if the toilet is well connected
see the 12V connection scheme

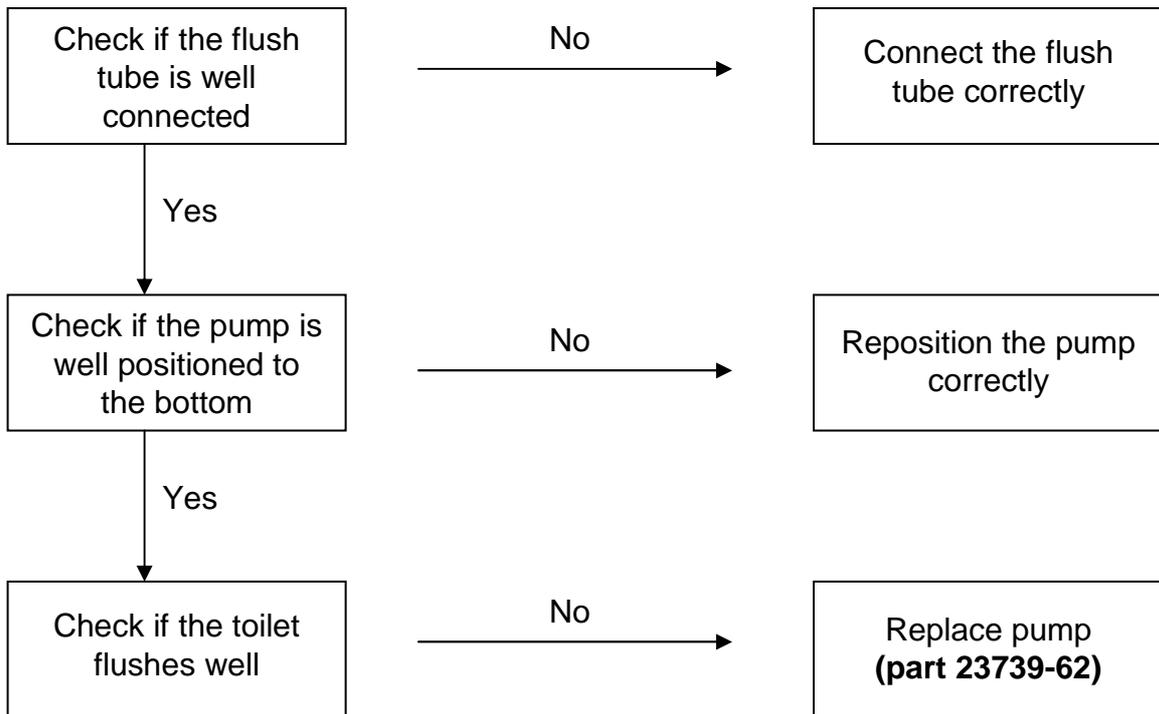
1. No flush C200CW

Repair instruction for 23739-62 you can find in the repair instructions chapter and/or on our website www.thetford.eu

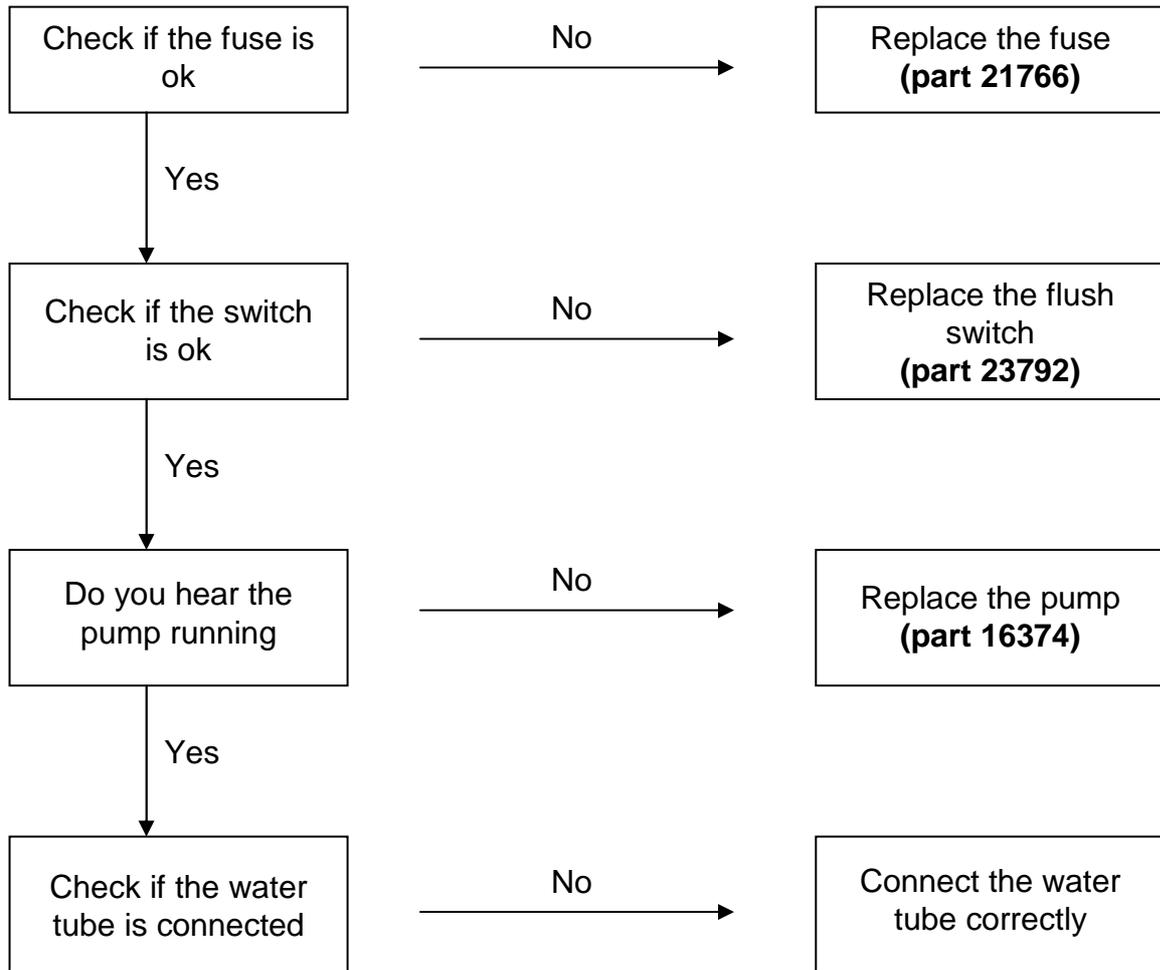
1. No flush C200CWE

Before starting, check if the toilet is well connected
see the 12V connection scheme

Repair instructions you can find in the repair
instructions chapter and/or on our website
www.thetford.eu

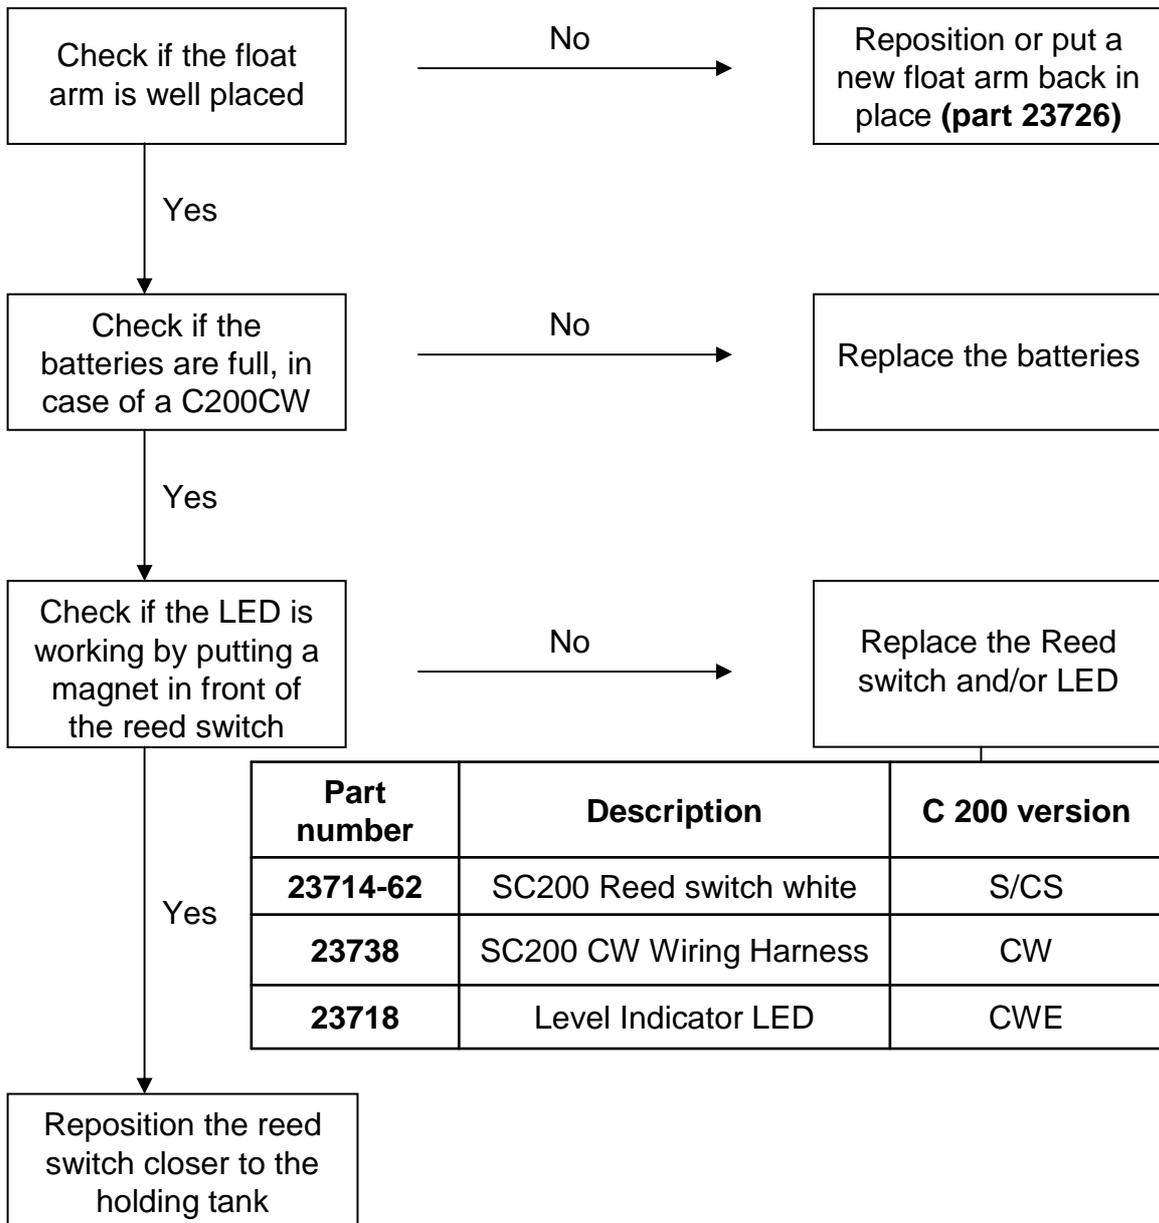
2. No level indication of the C200 Holding Tank

Before starting, Check the connection wires at the control panel

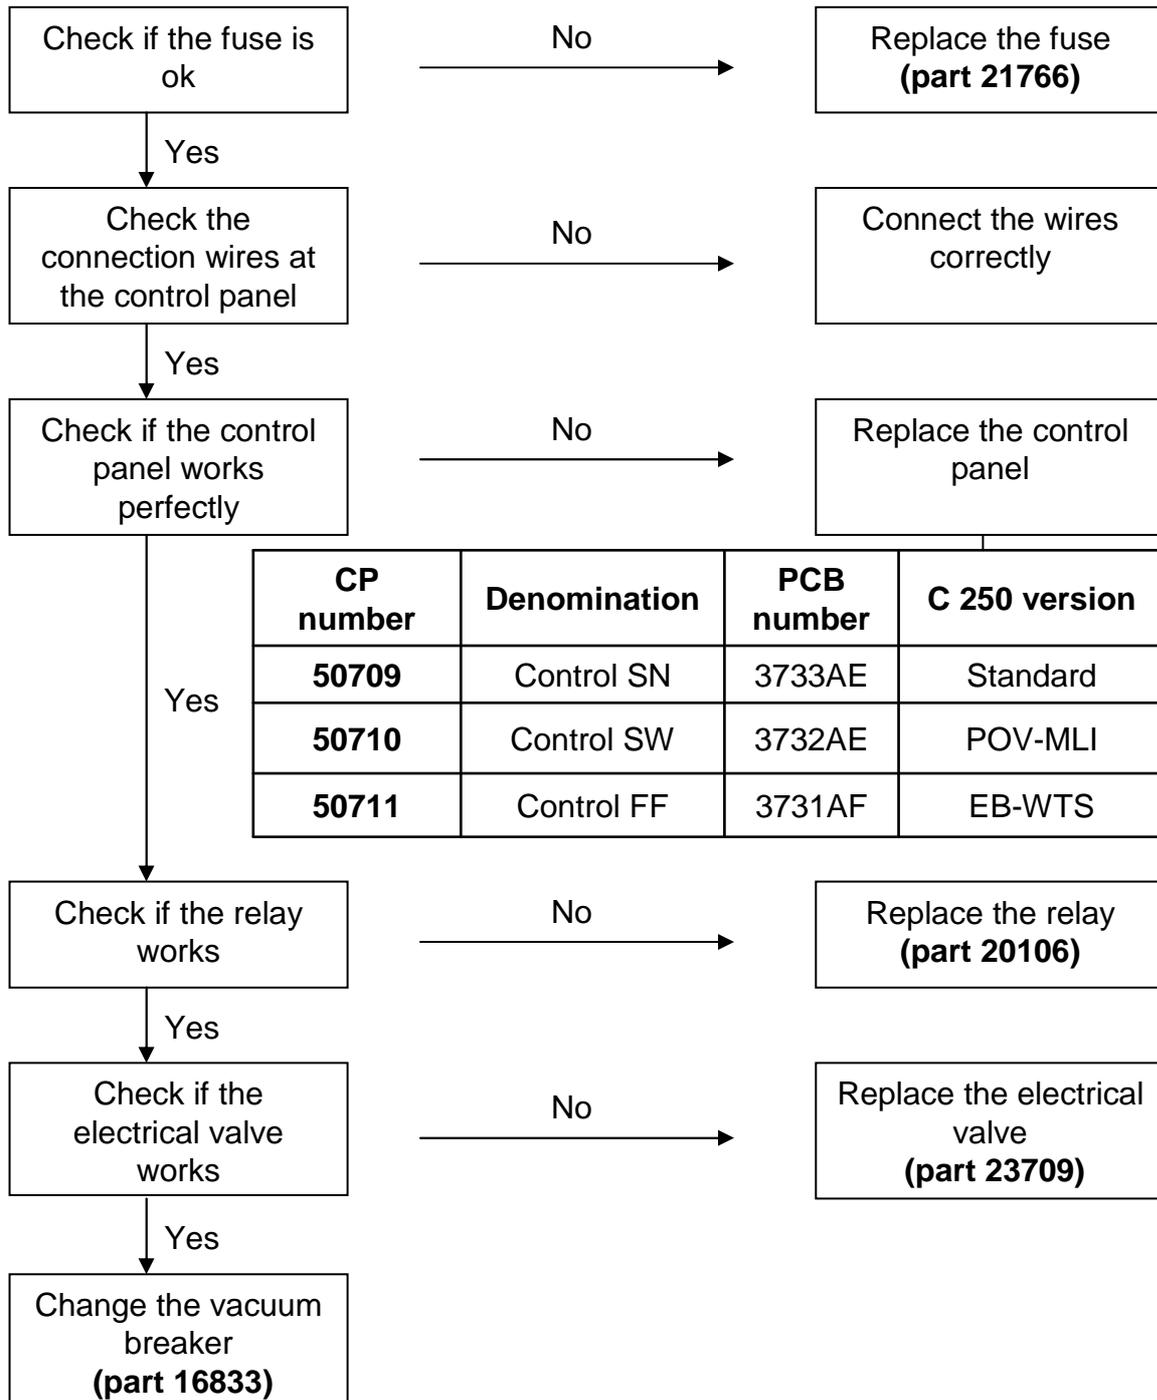
No flush C250CS

Ensure that the vehicle water pump functions

Before starting, check if the toilet is well connected
see the 12V connection scheme

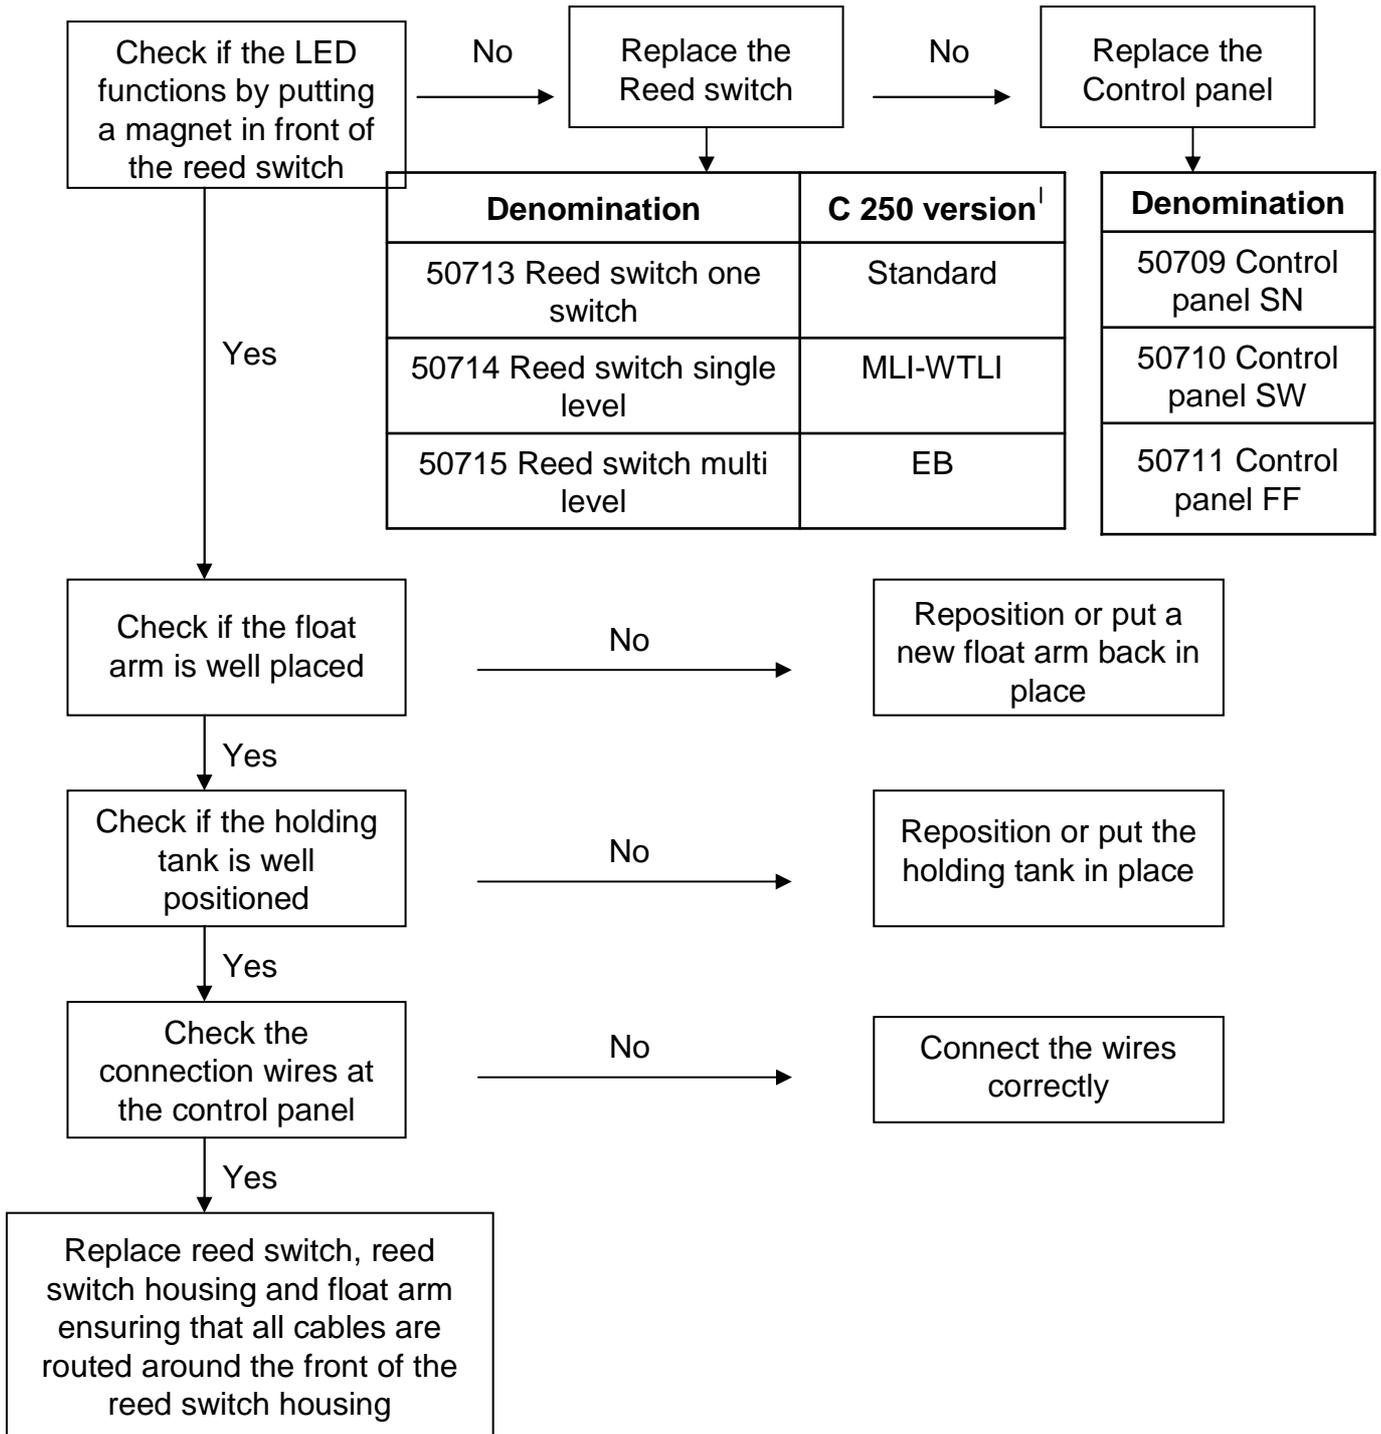
No level indication of the C250 Holding Tank

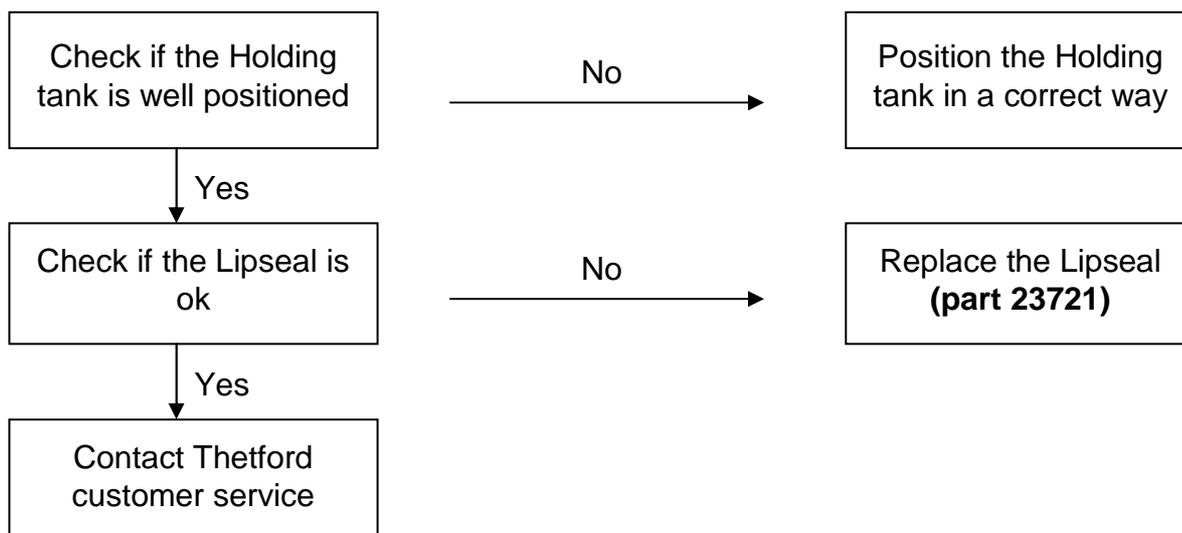
➤ Leakage between the bowl and the Holding Tank

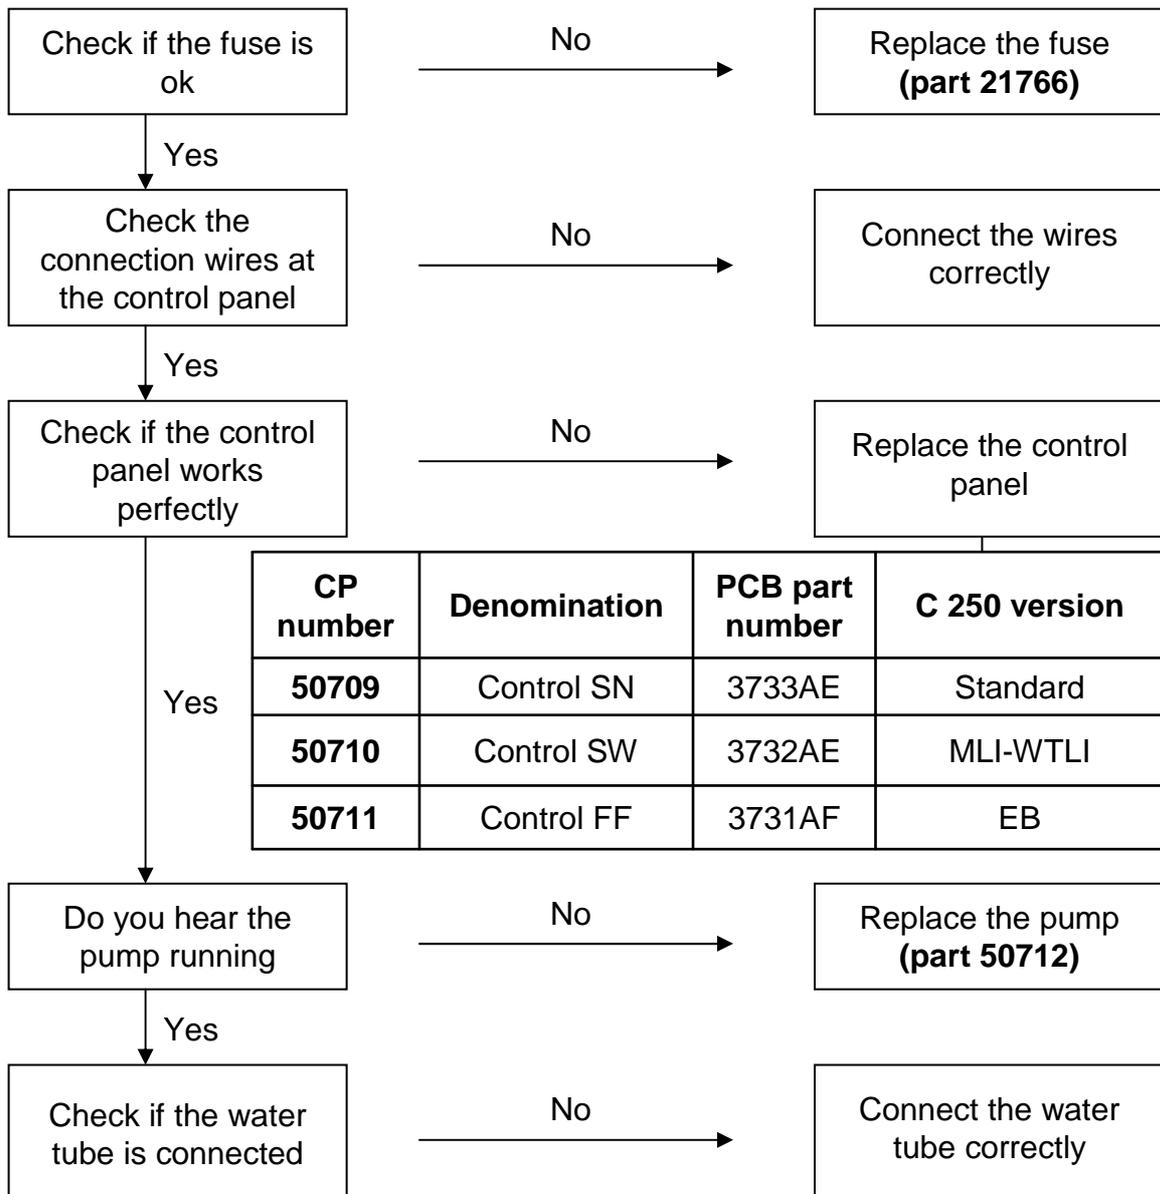
No flush C250 CWE

Before starting, check if the toilet is well connected
see the 12V connection scheme

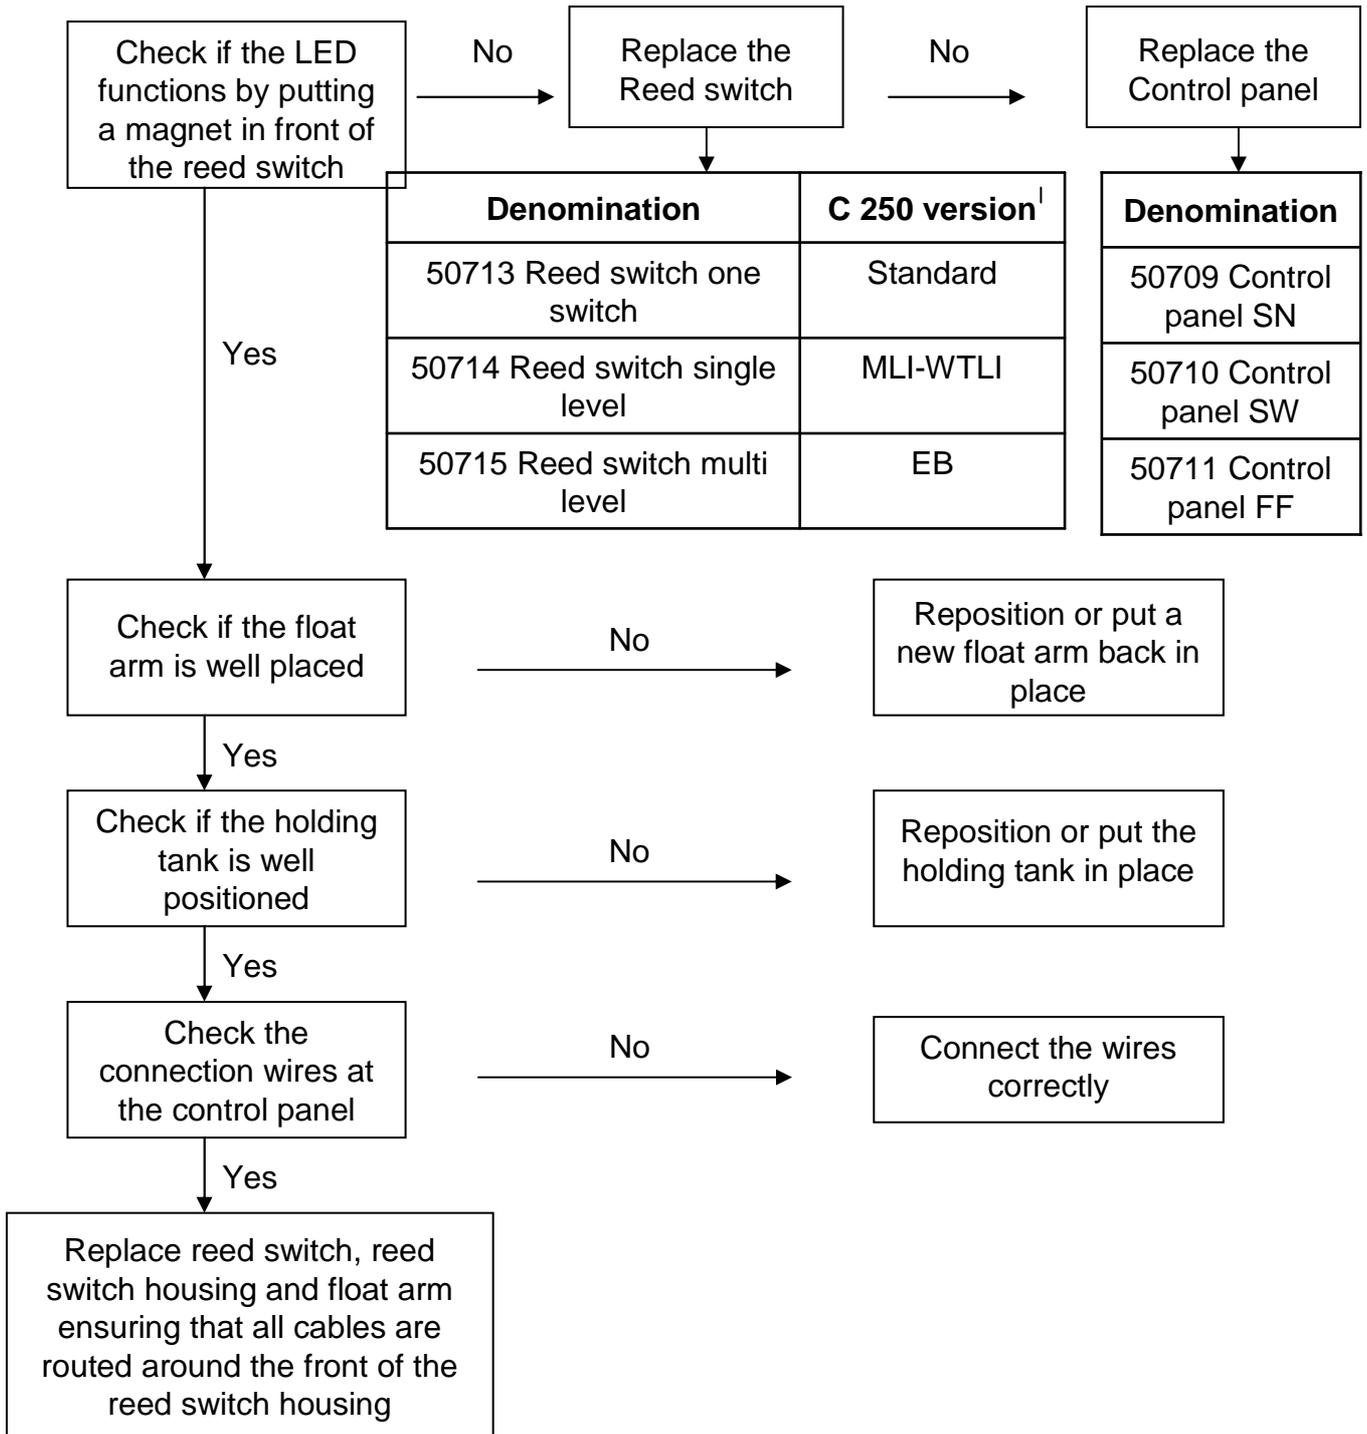
No level indication of the C250 Holding Tank

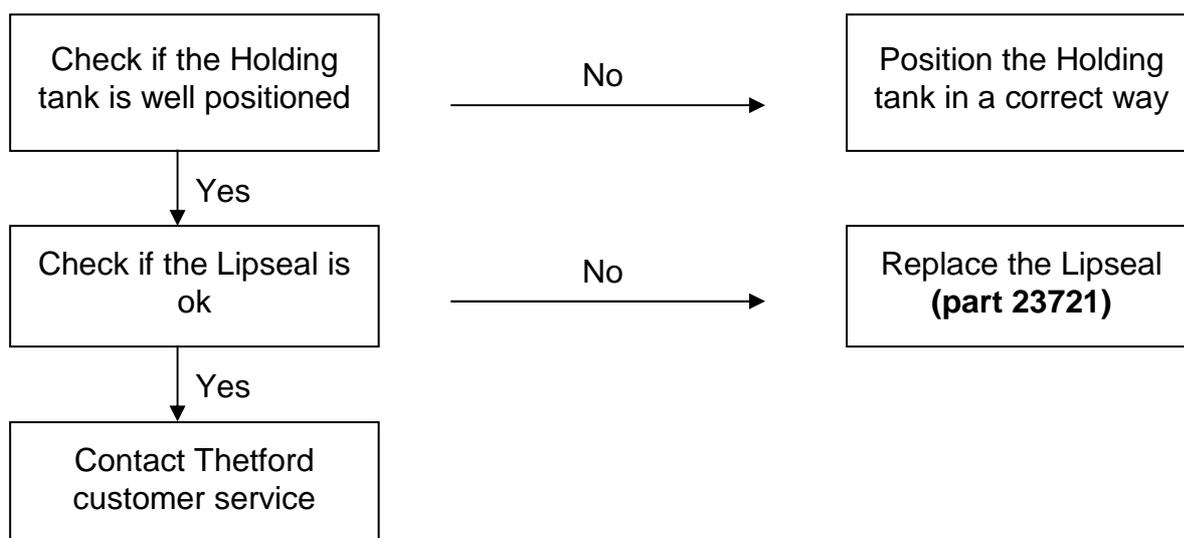
➤ Leakage between the bowl and the Holding Tank

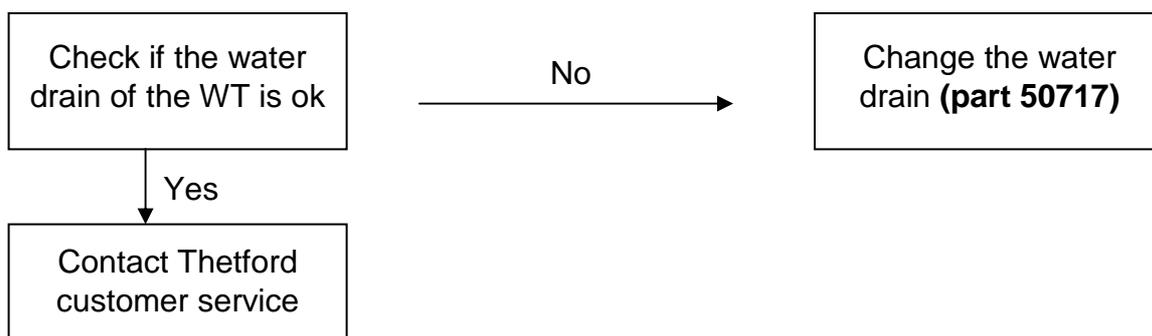
➤ Leakage at the water tank

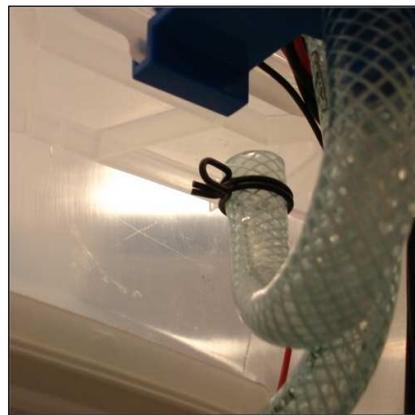
Leakage pump C250CWE

Issue : Leakage at welded connection between pump-housing and pump bracket

Solution : More rigid tube connection and clamp have been added

Implementation : As from September 24 2007

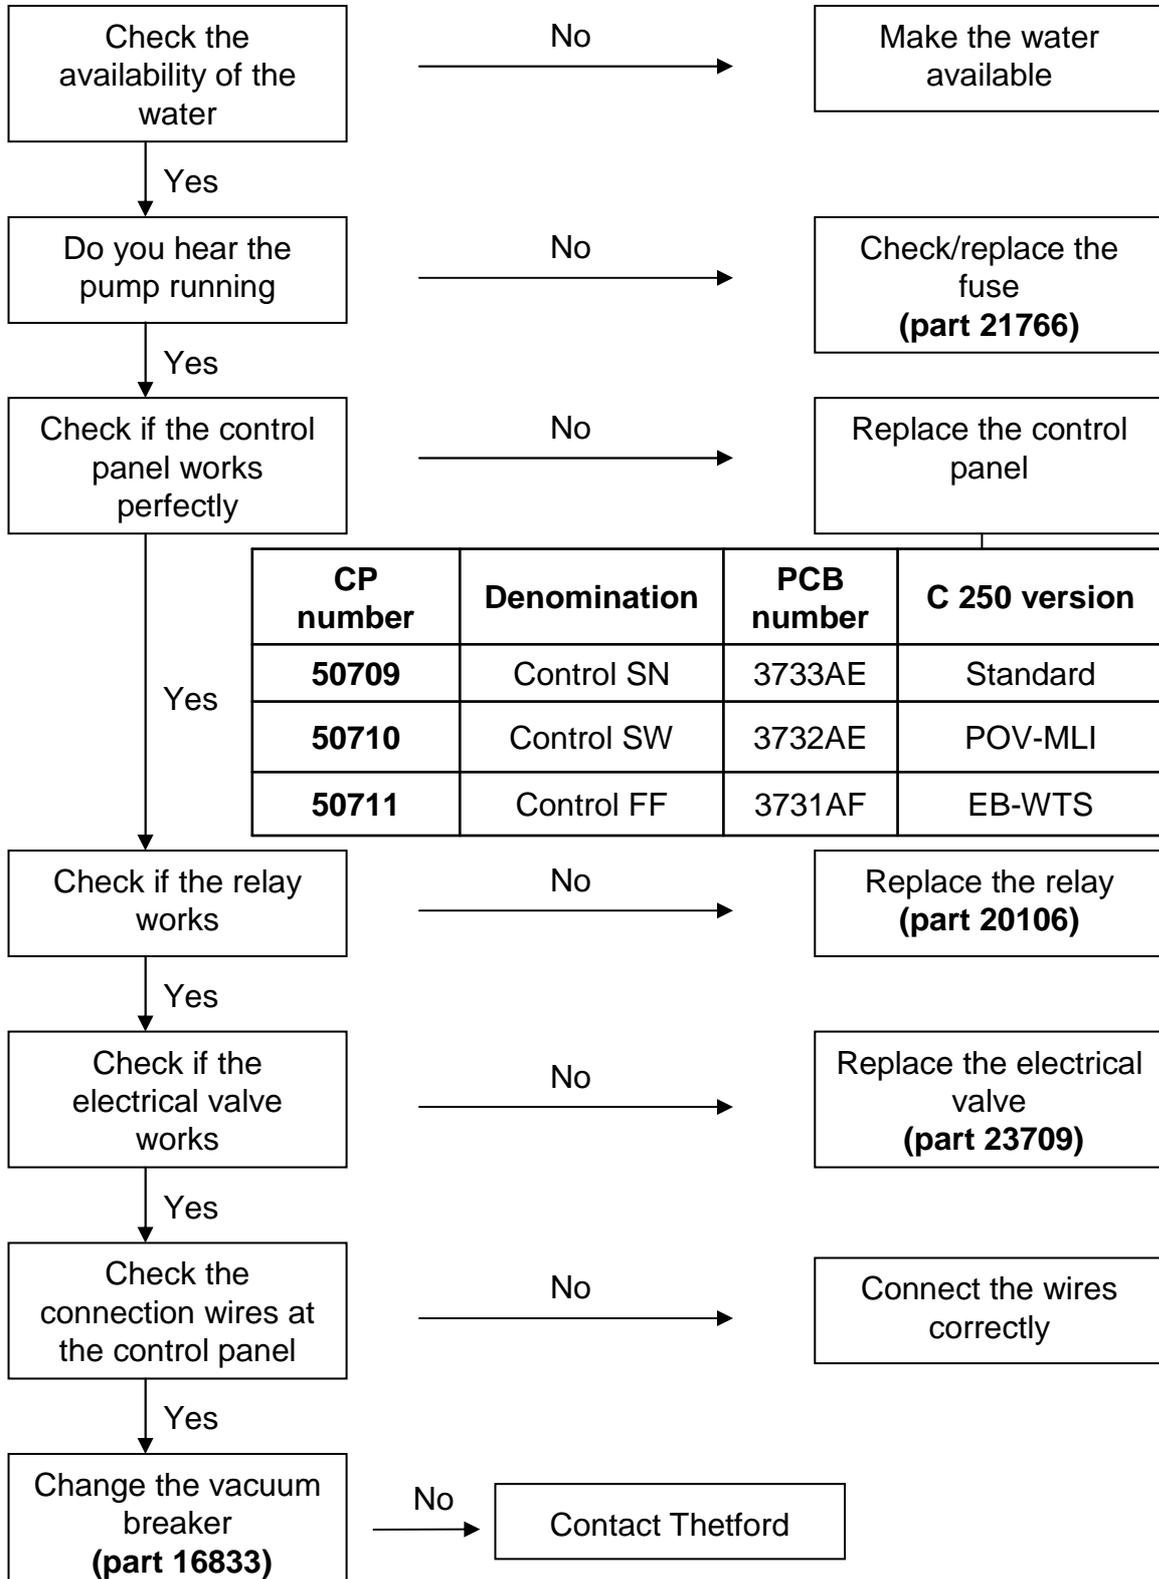
No flush C250S

Ensure that the vehicle water pump functions

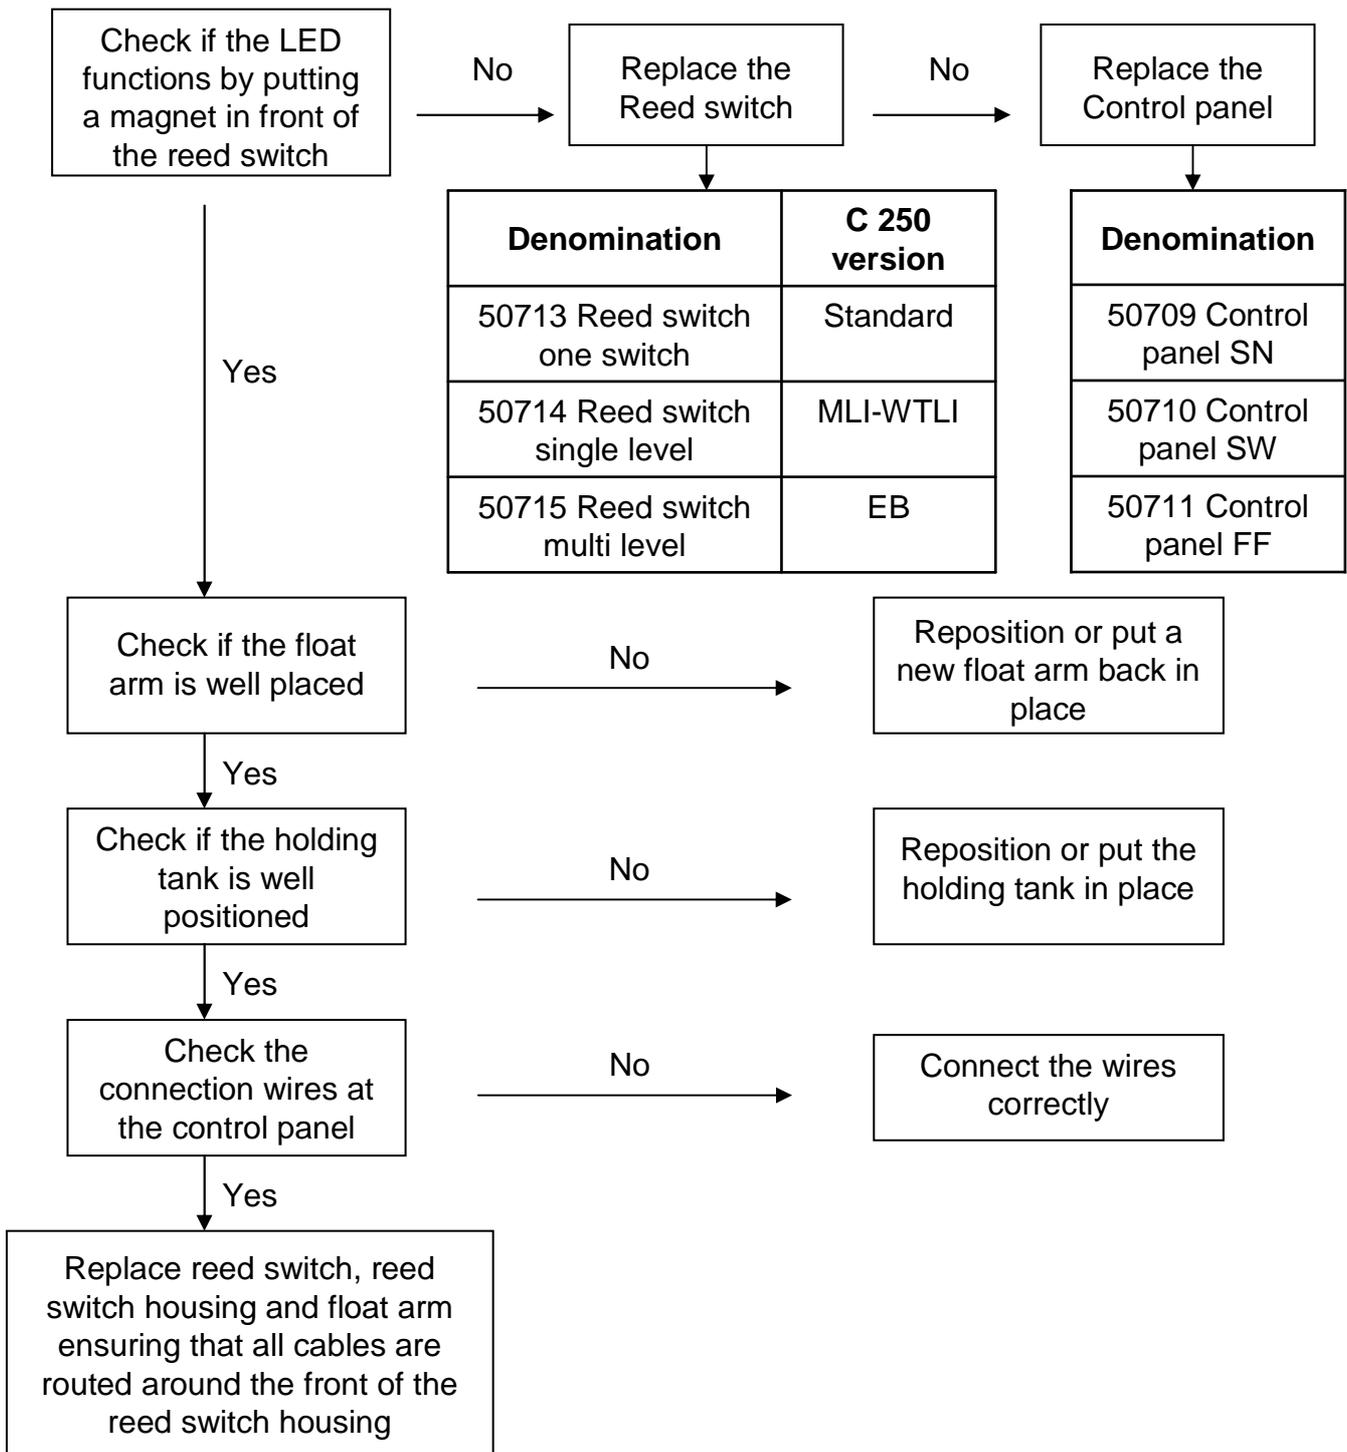
No level indication of the C250 Holding Tank

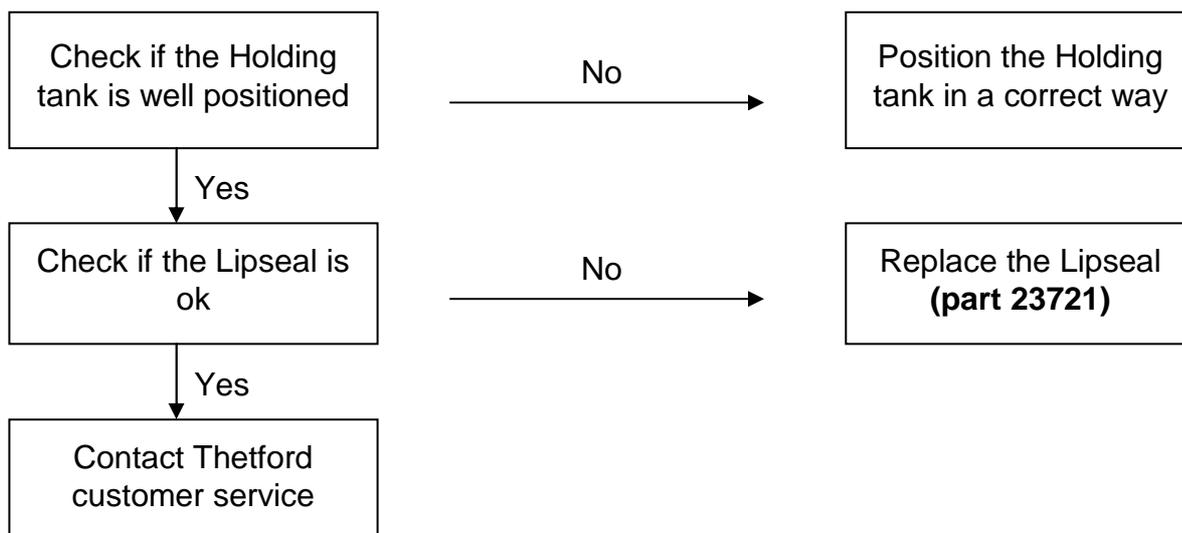
➤ Leakage between the bowl and the Holding Tank

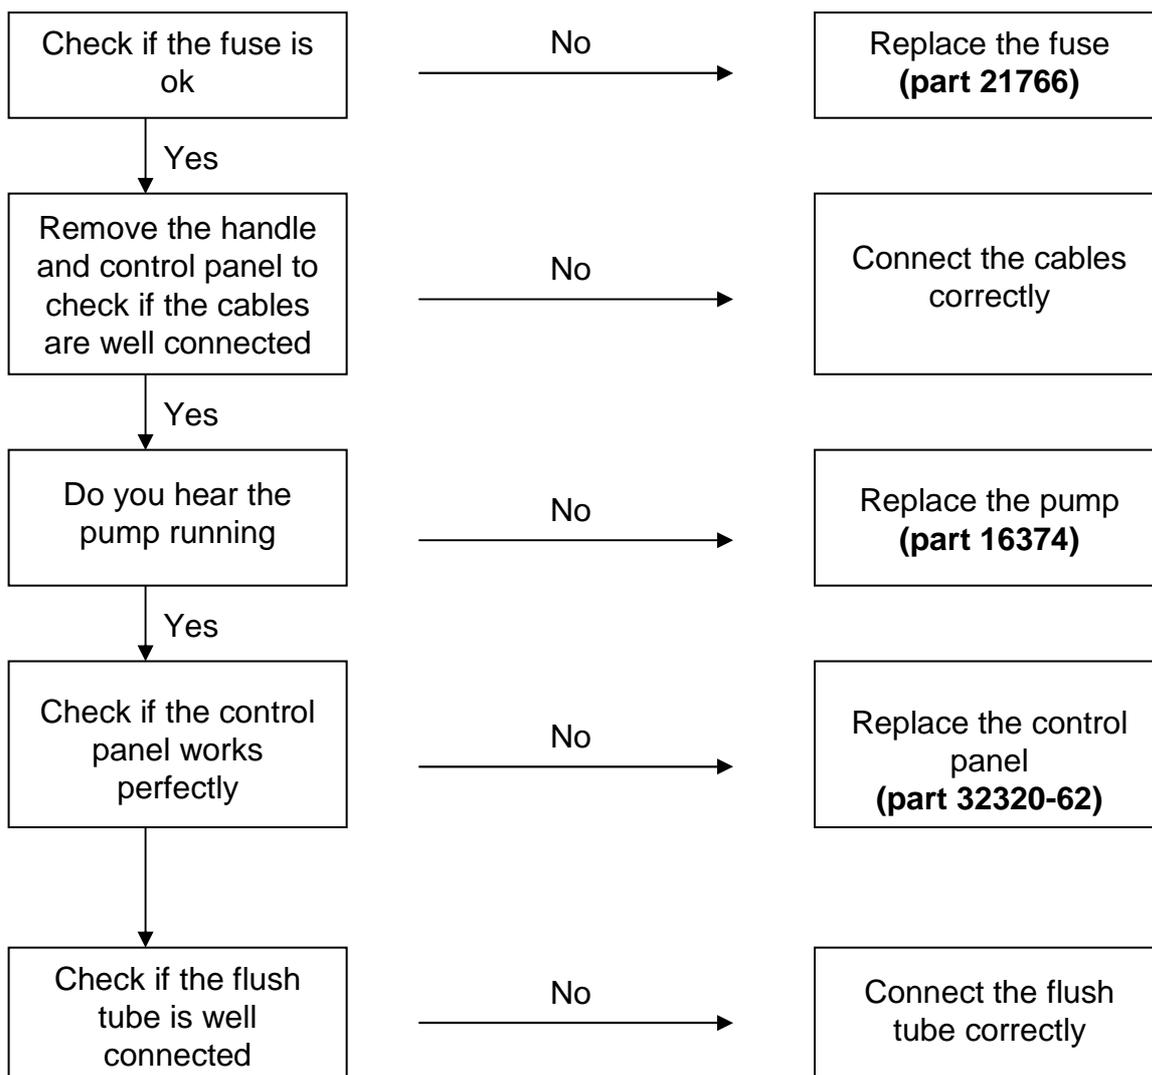
No flush C402C

Before starting, check if the toilet is well connected
see the 12V connection scheme

Repair instructions you can find in the repair instructions chapter and/or on our website www.thetford.eu

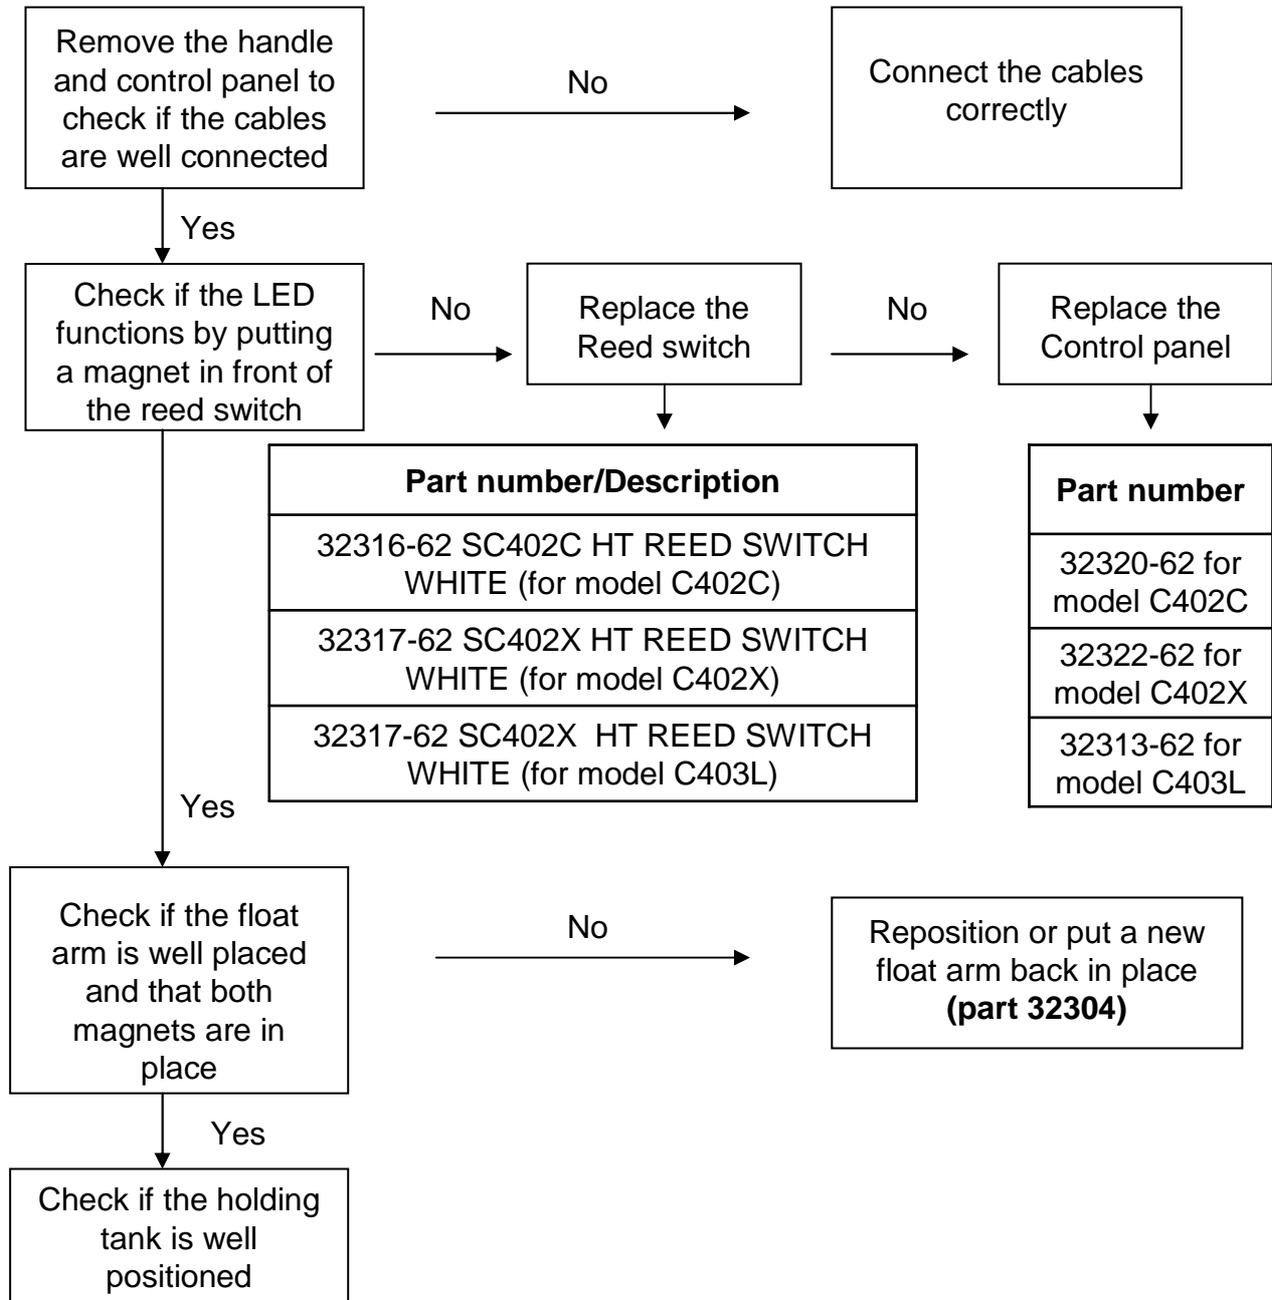
No level indication of the C400 Holding Tank

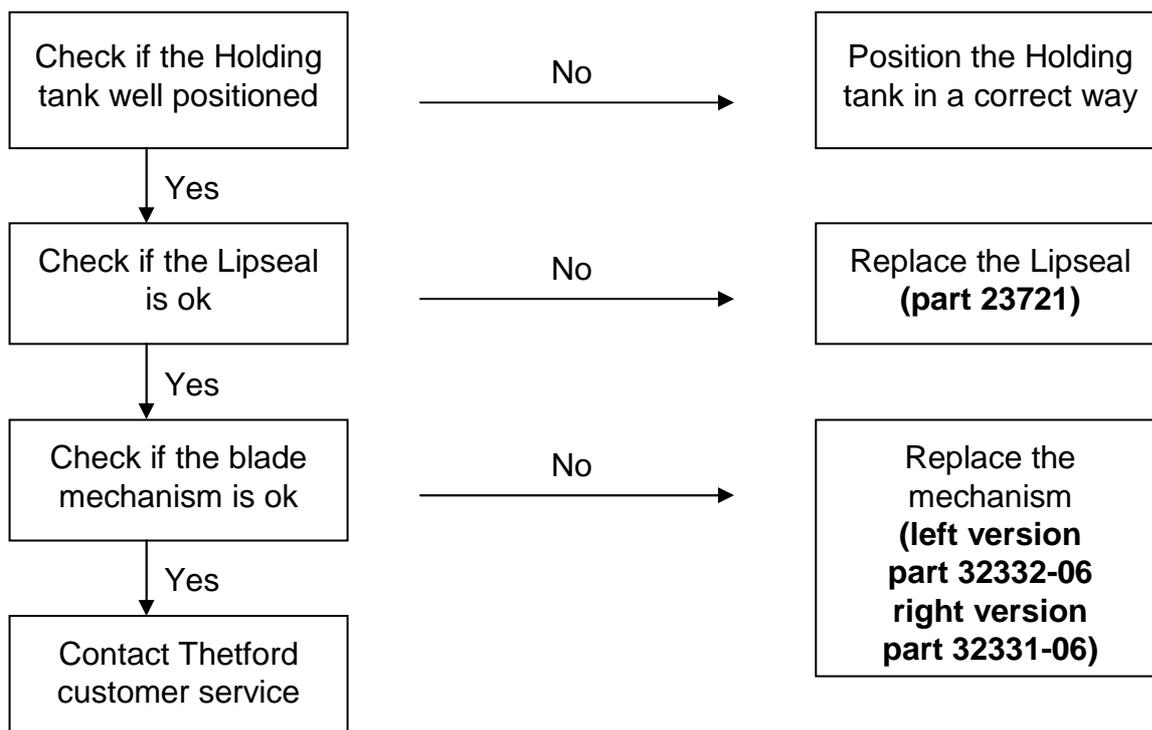
➤ Leakage between the bowl and the Holding tank

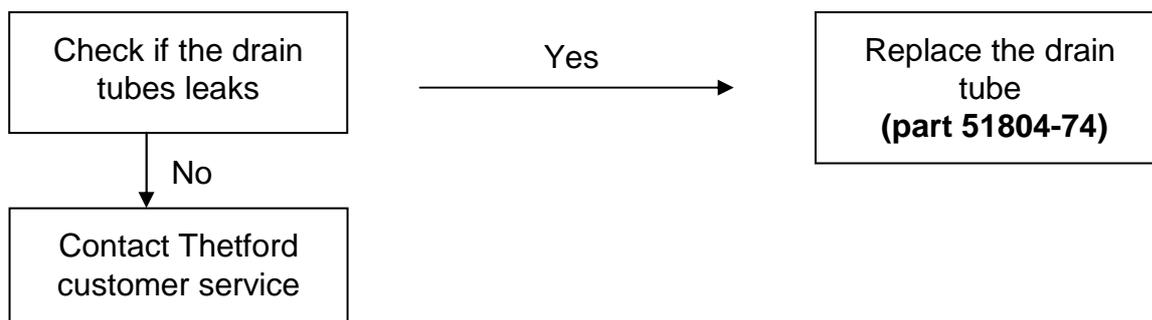
➤ Leakage at the Water tank

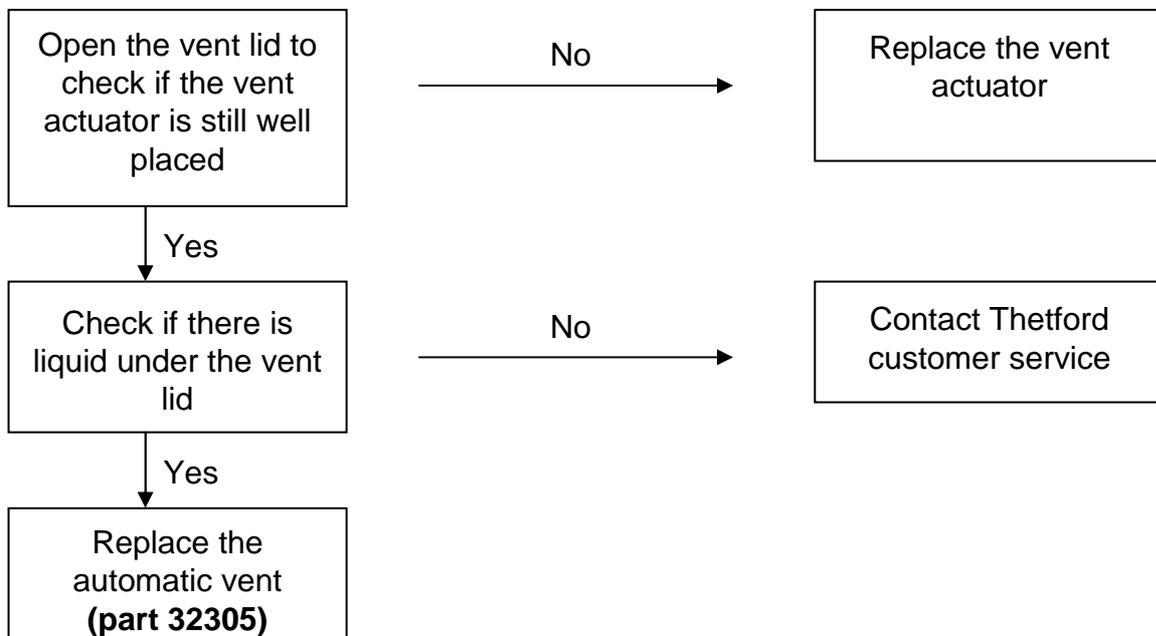
▪ **Leakage at the vent lid**

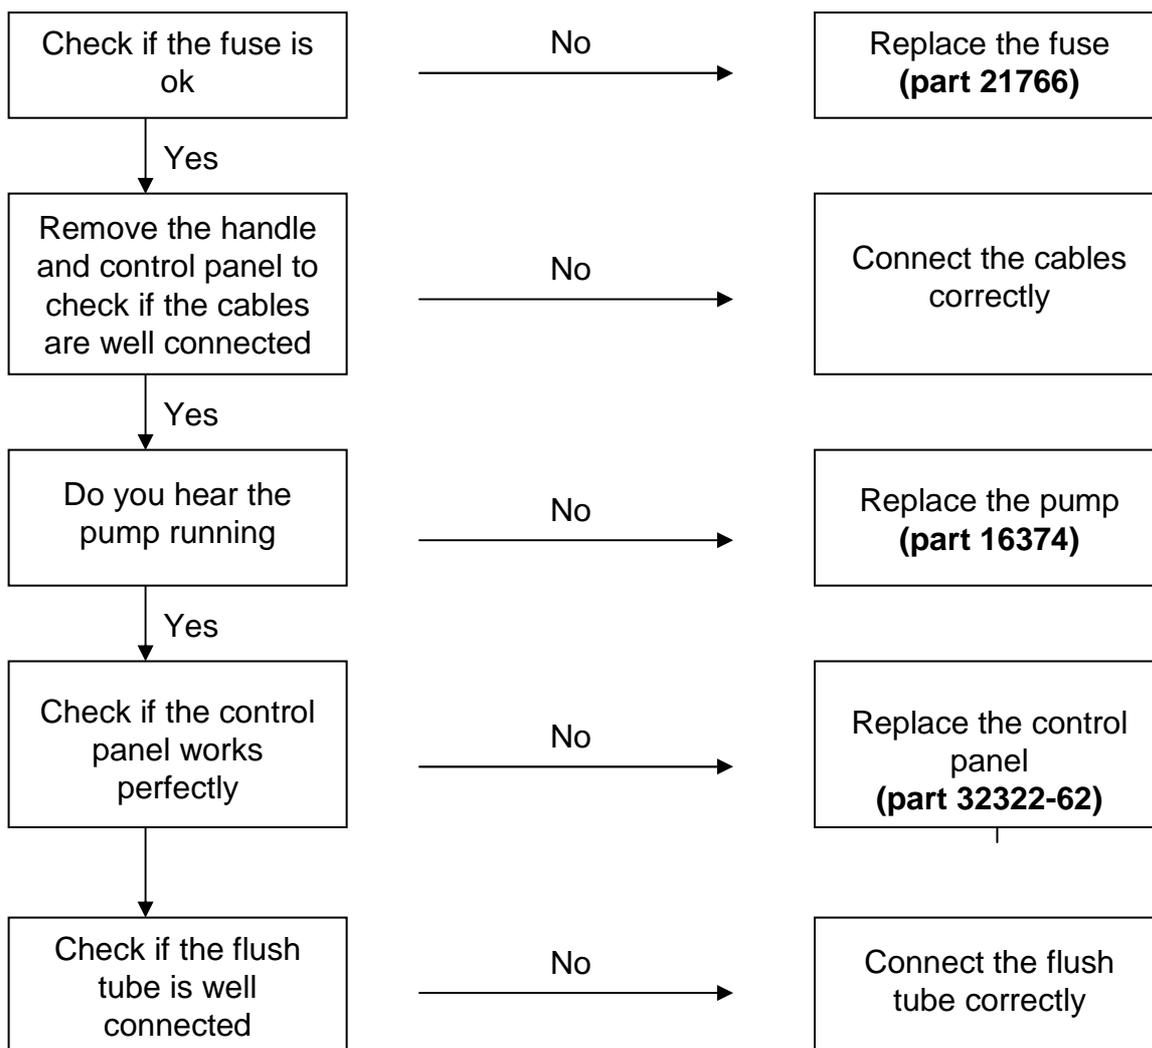
No flush C402X

Before starting, check if the toilet is well connected
see the 12V connection scheme

Repair instructions you can find in the repair instructions chapter and/or on our website www.thetford.eu
