1. No flush C200S/CS

Before starting, check if the toilet is well connected
see the 12V connection scheme

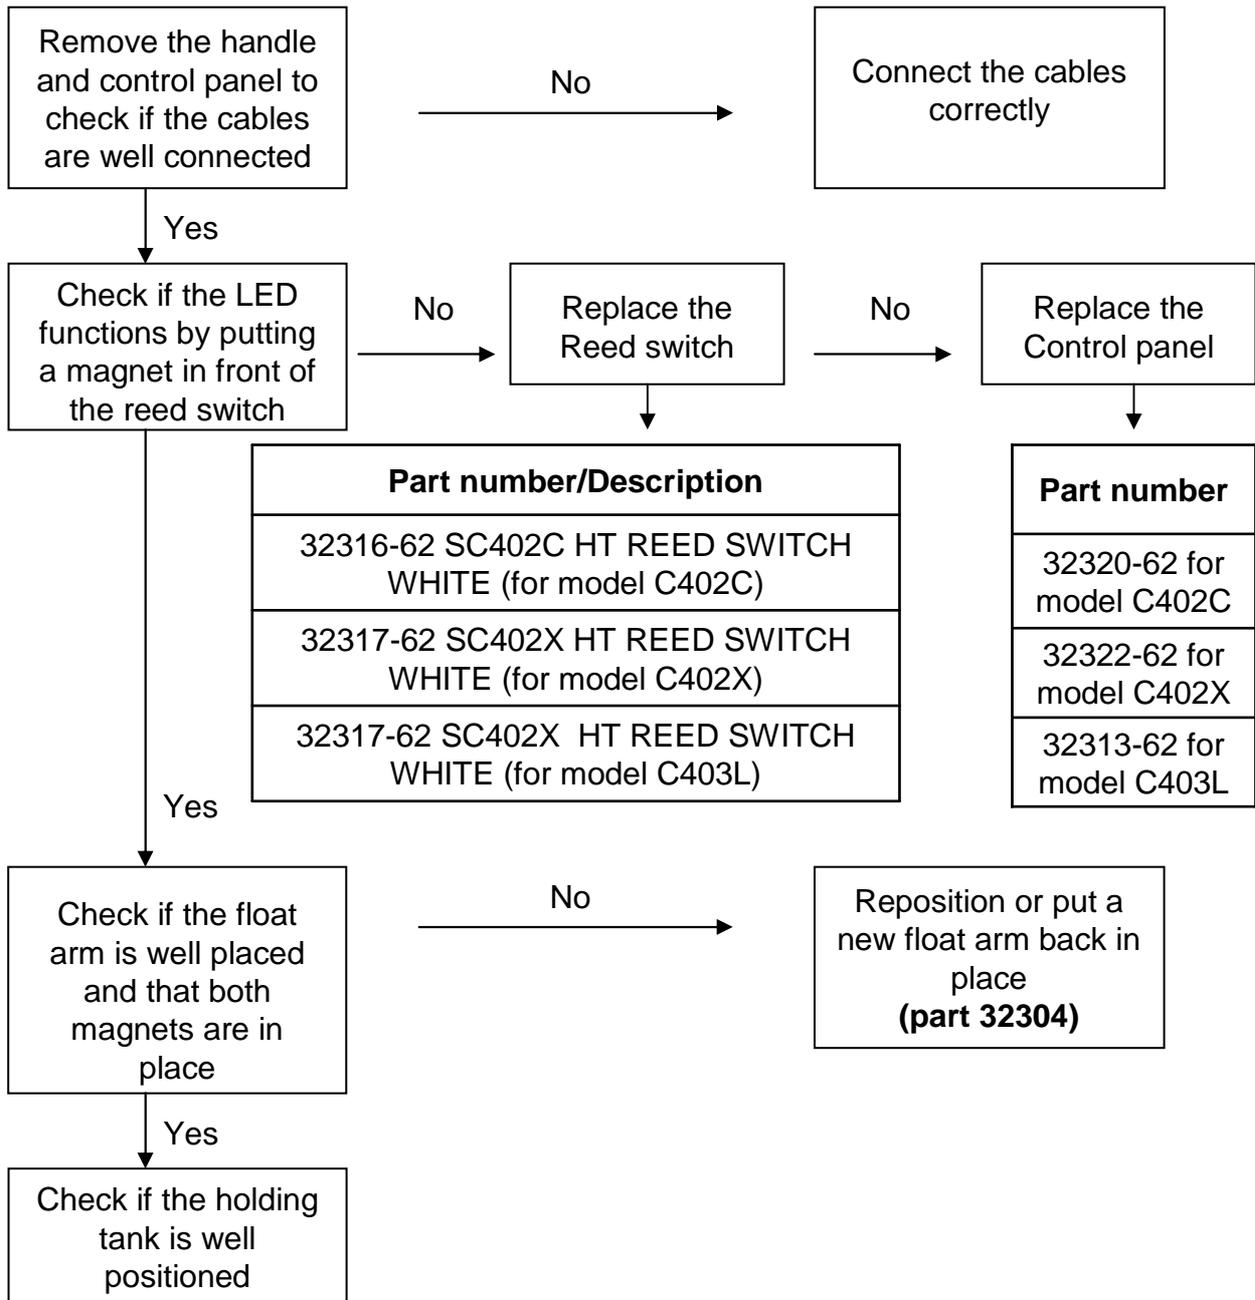
No level indication of the C400 Holding Tank

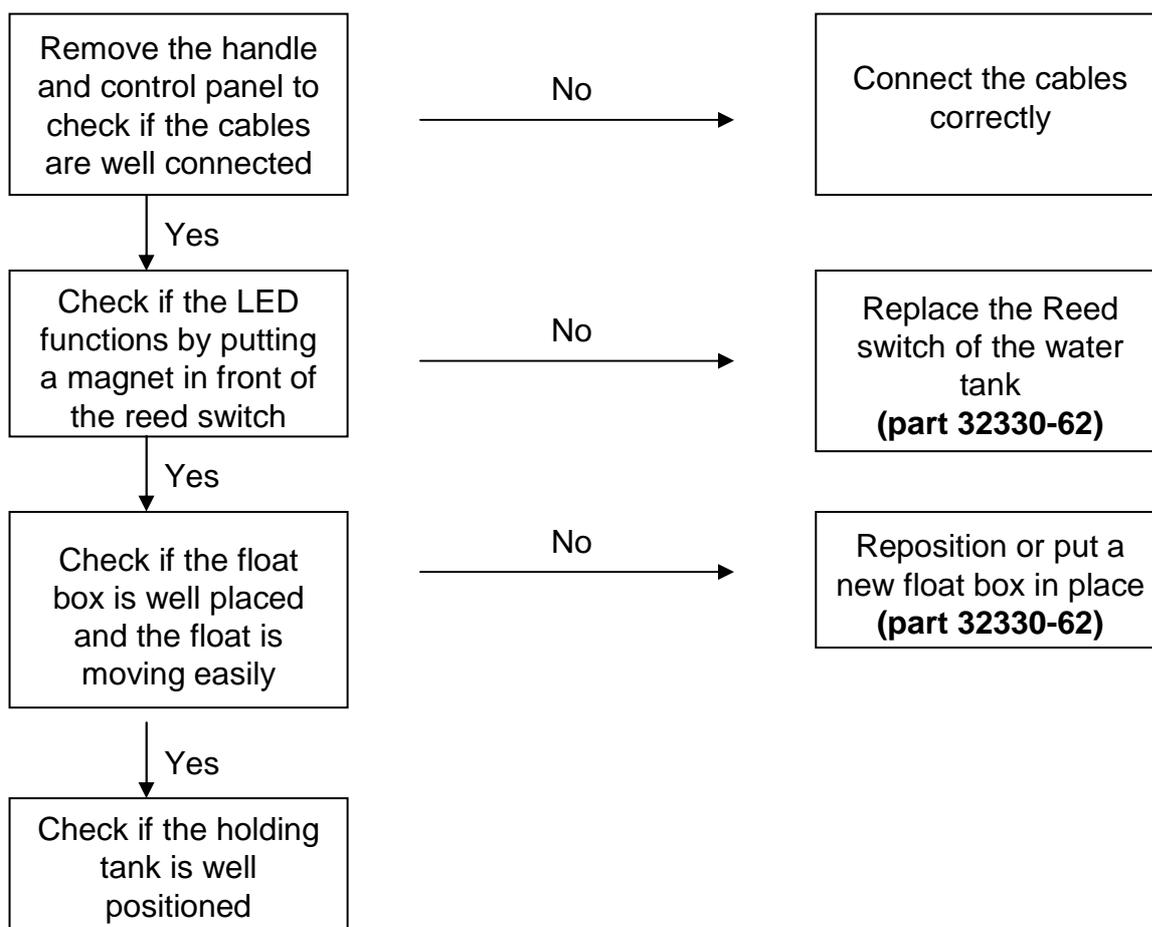
No level indication of the C402X Water tank

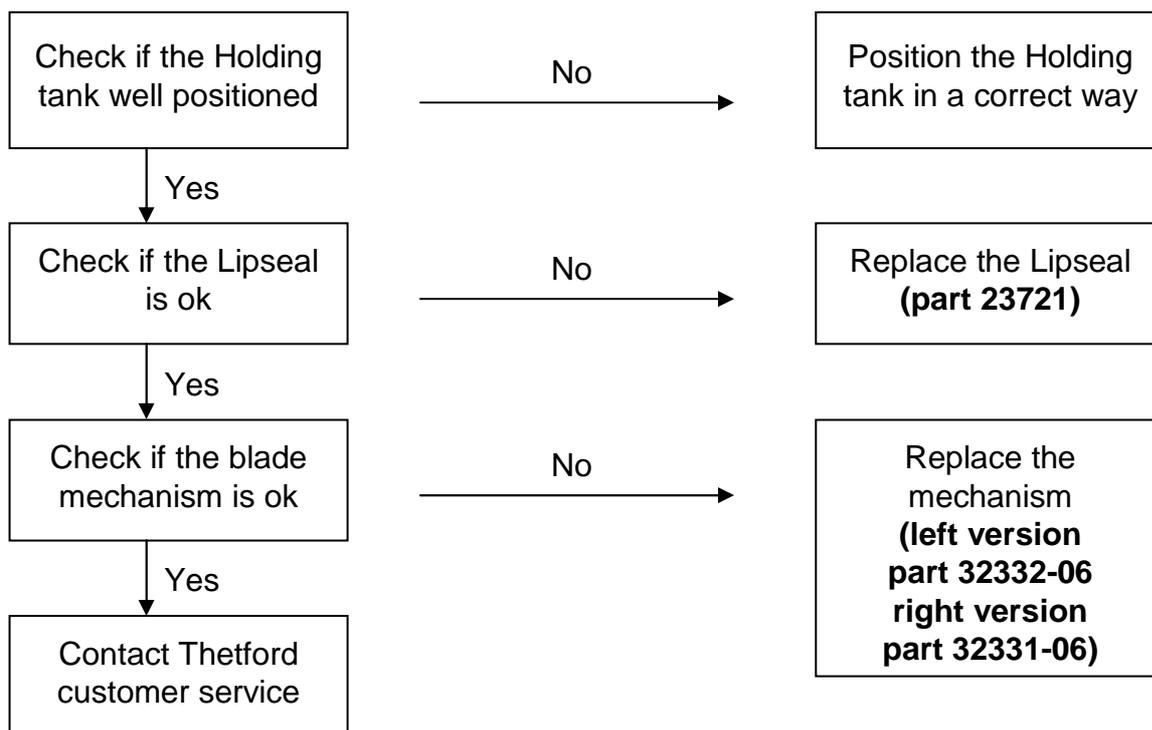
➤ Leakage between the bowl and the Holding tank

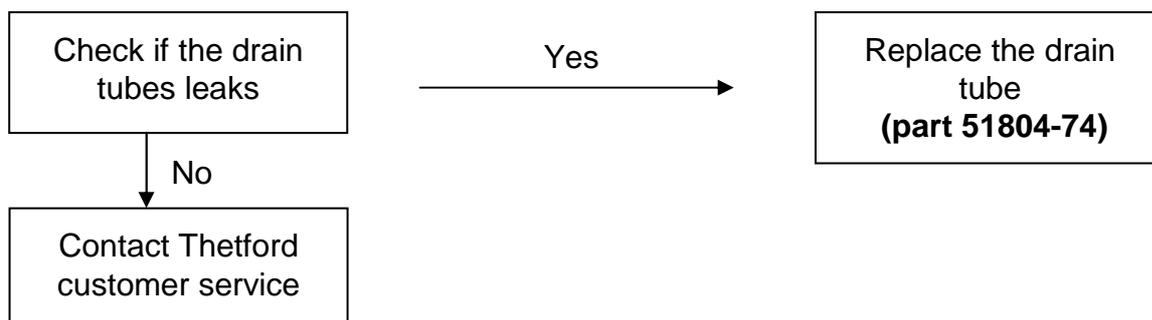
➤ Leakage at the Water tank

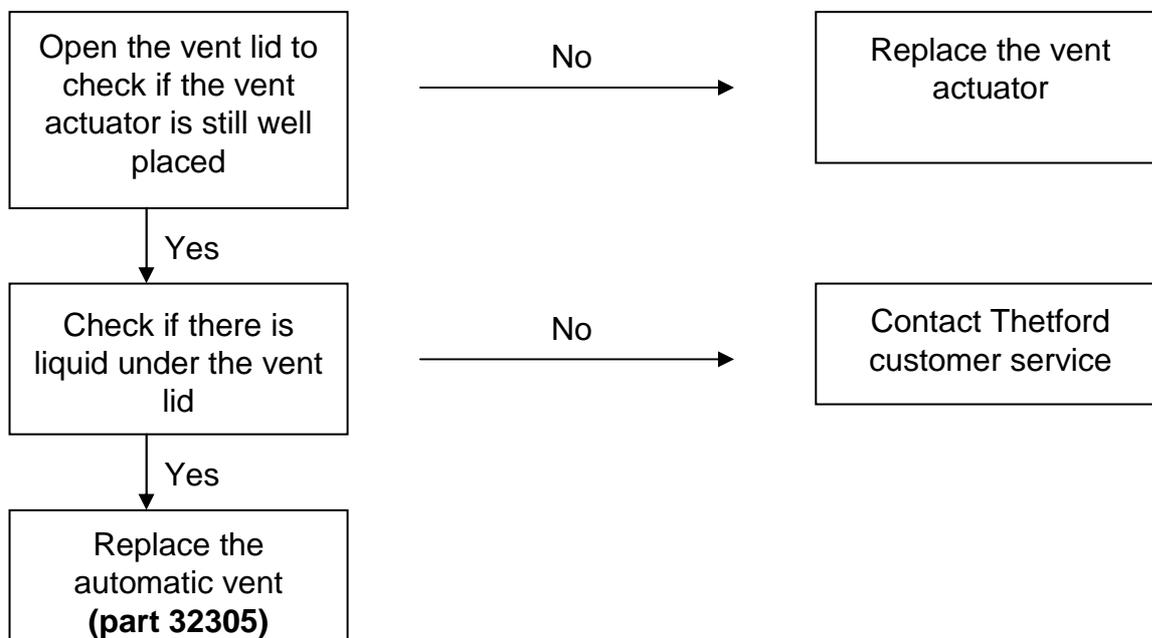
▪ **Leakage at the vent lid**

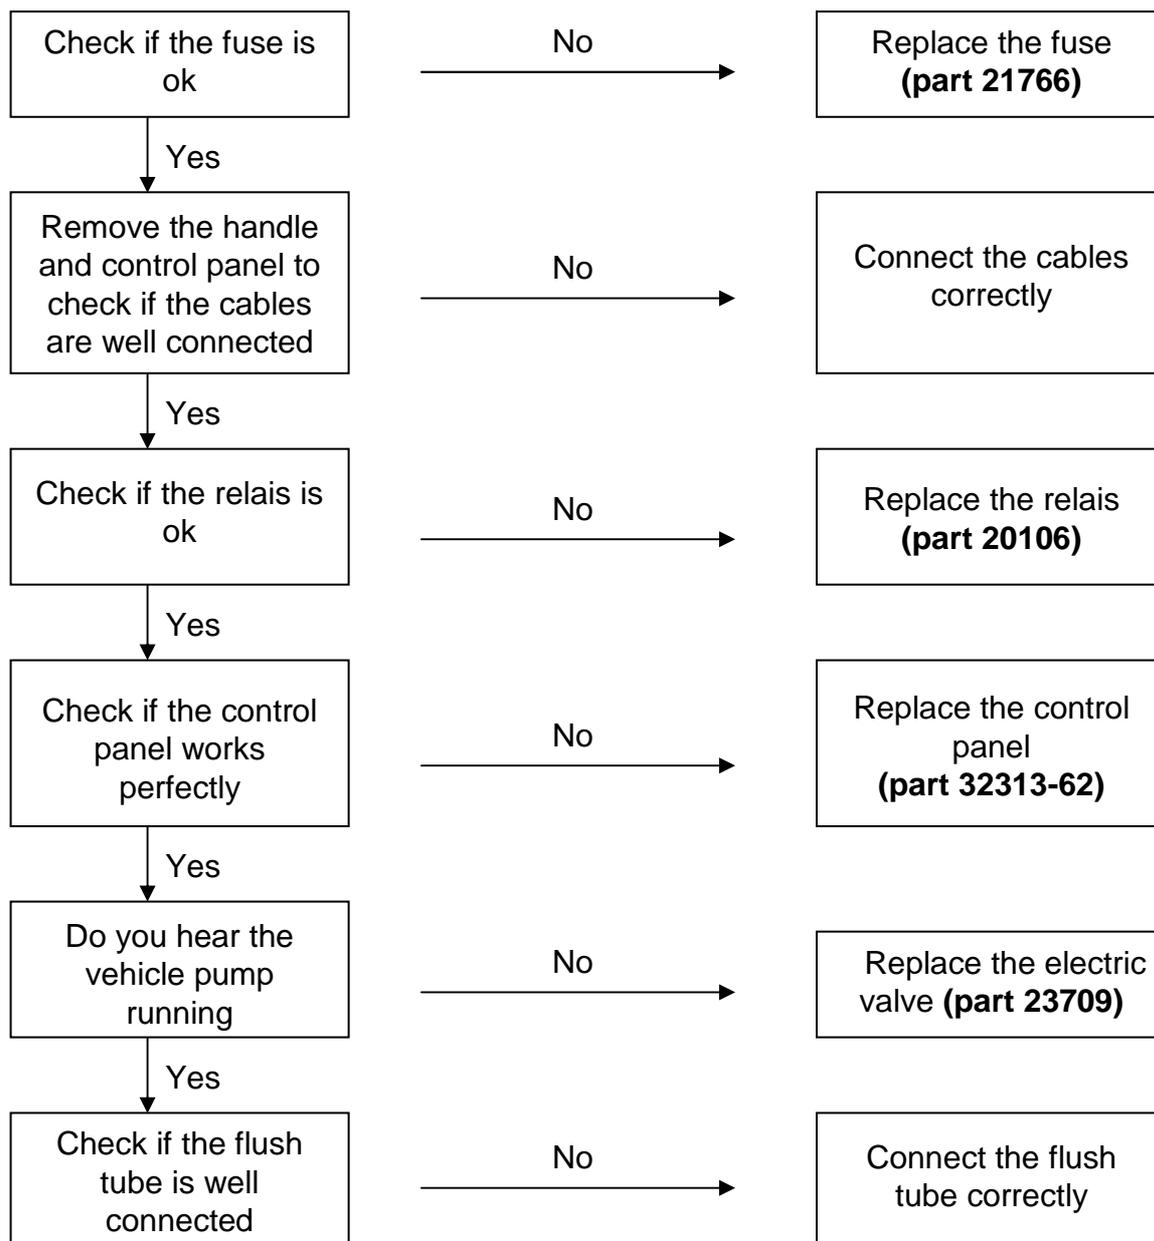
No flush C403L

Before starting, check if the toilet is well connected, water is available and the vehicle pump is working well. See the 12V connection scheme

Repair instructions you can find in the repair instructions chapter and/or on our website www.thetford.eu

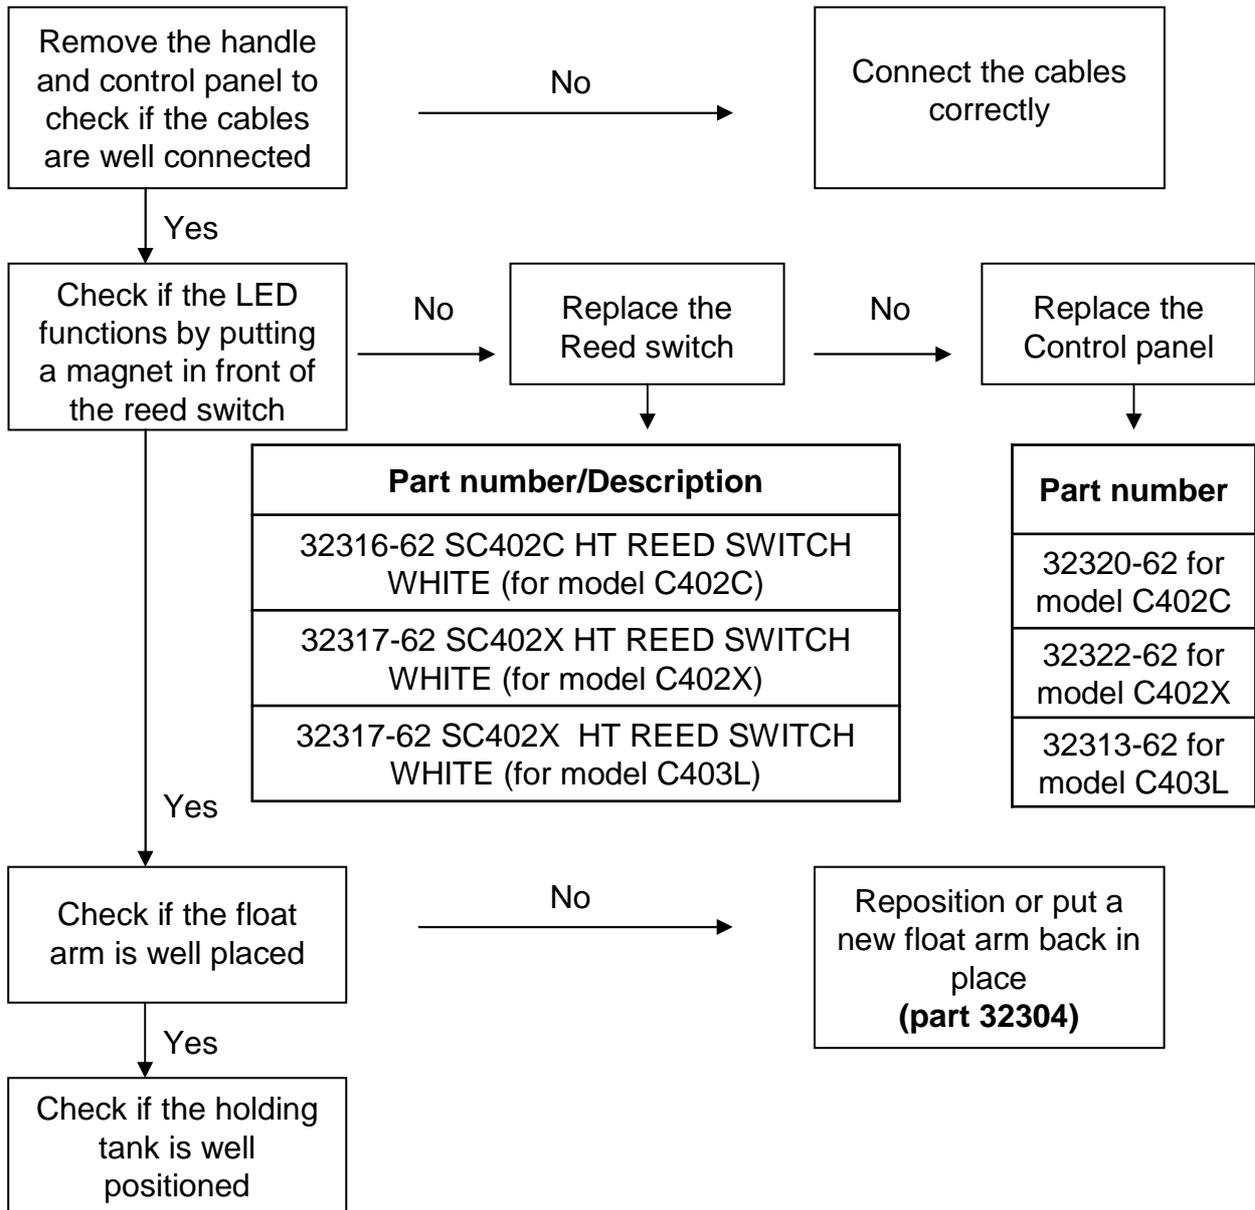
No level indication of the C400 Holding Tank

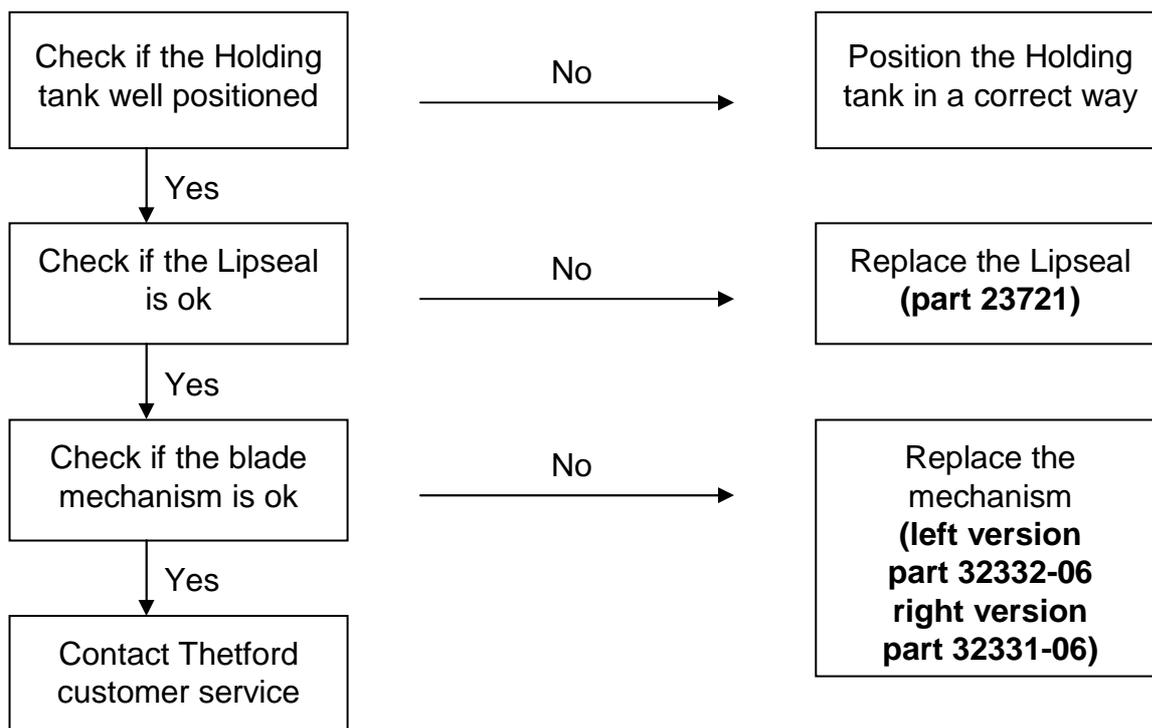
➤ Leakage between the bowl and the Holding tank

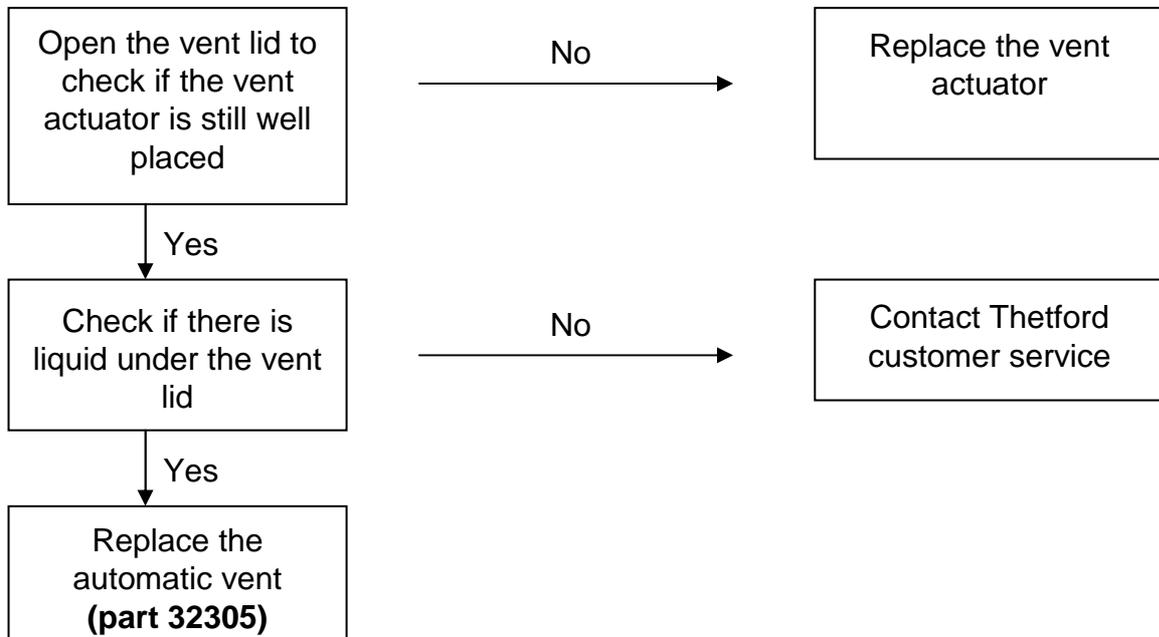
▪ **Leakage at the vent lid**

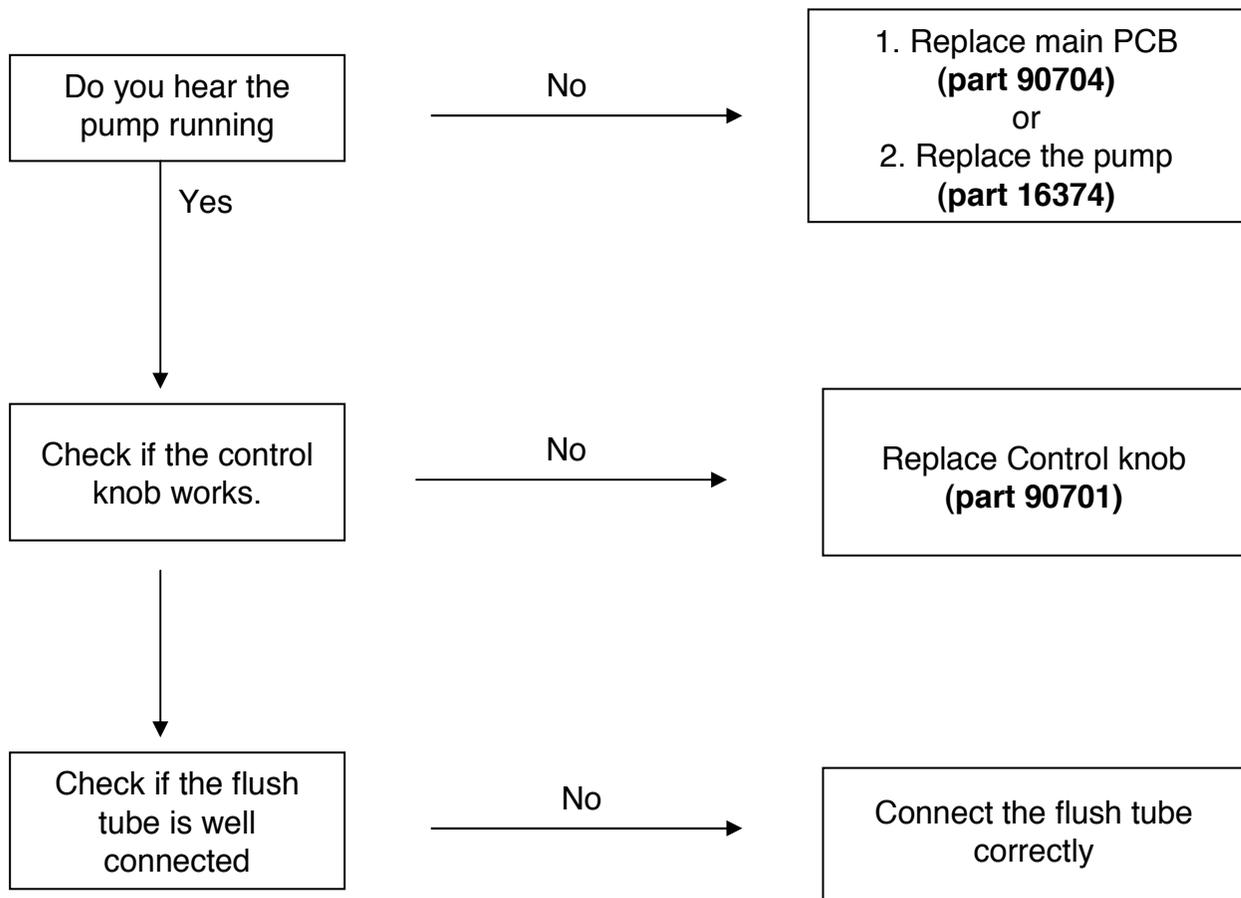
No flush C500C

Before starting, ensure that the toilet is connected properly by checking the 12v diagram. Also ensure that the fresh water tank is full.

Repair instructions you can find in the repair instructions chapter and/or on our website www.thetford.eu

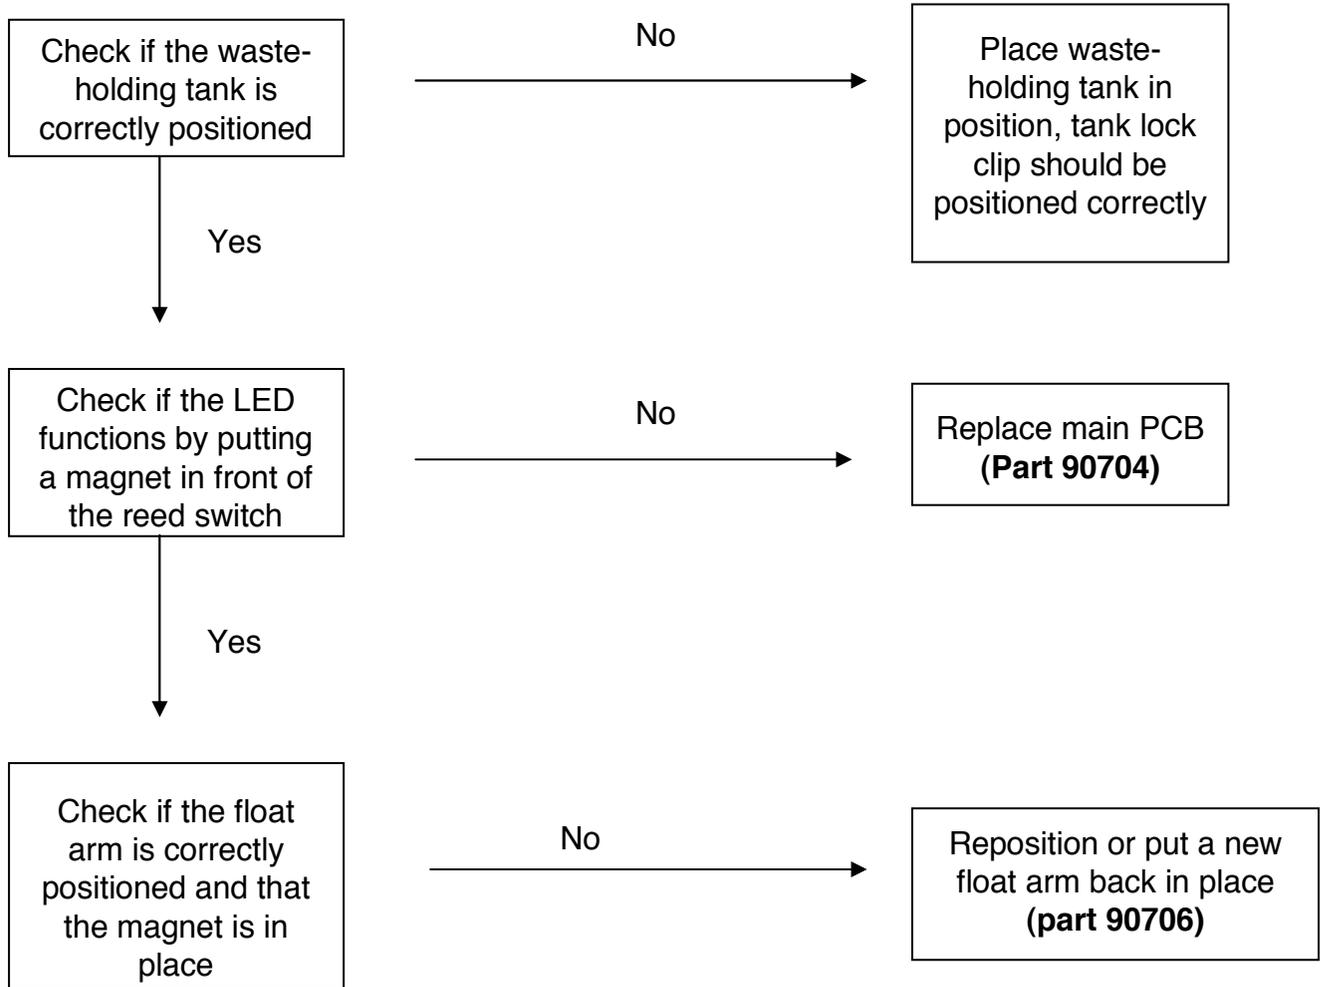
No level indication of the C500 Waste-Holding Tank

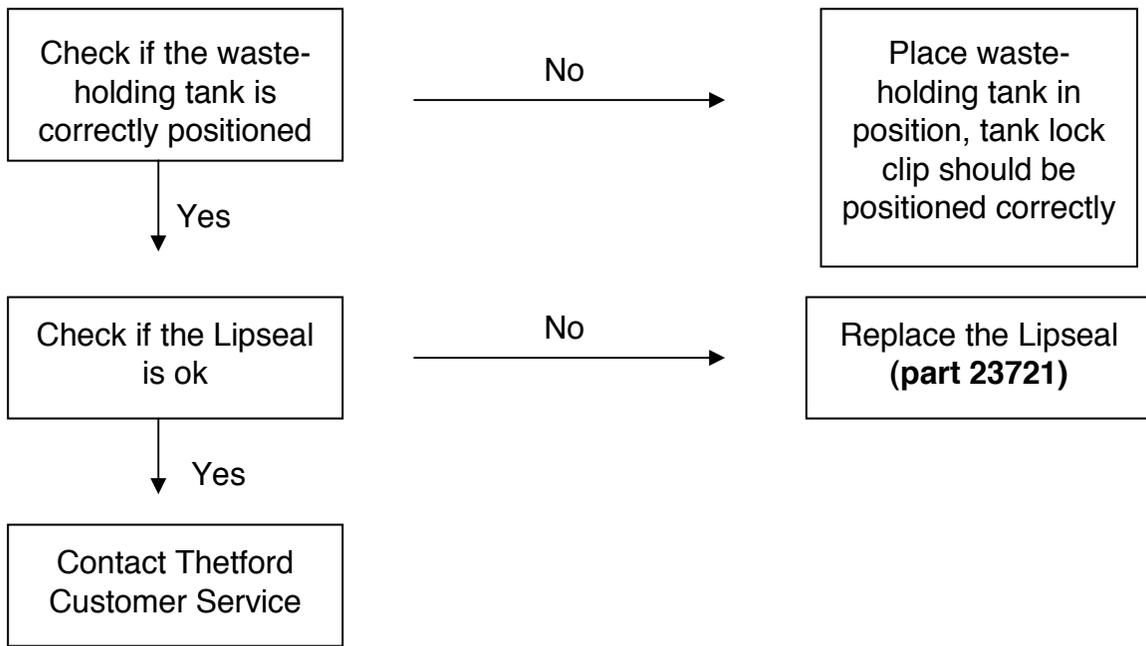
➤ Leakage between the bowl and the Waste-Holding tank

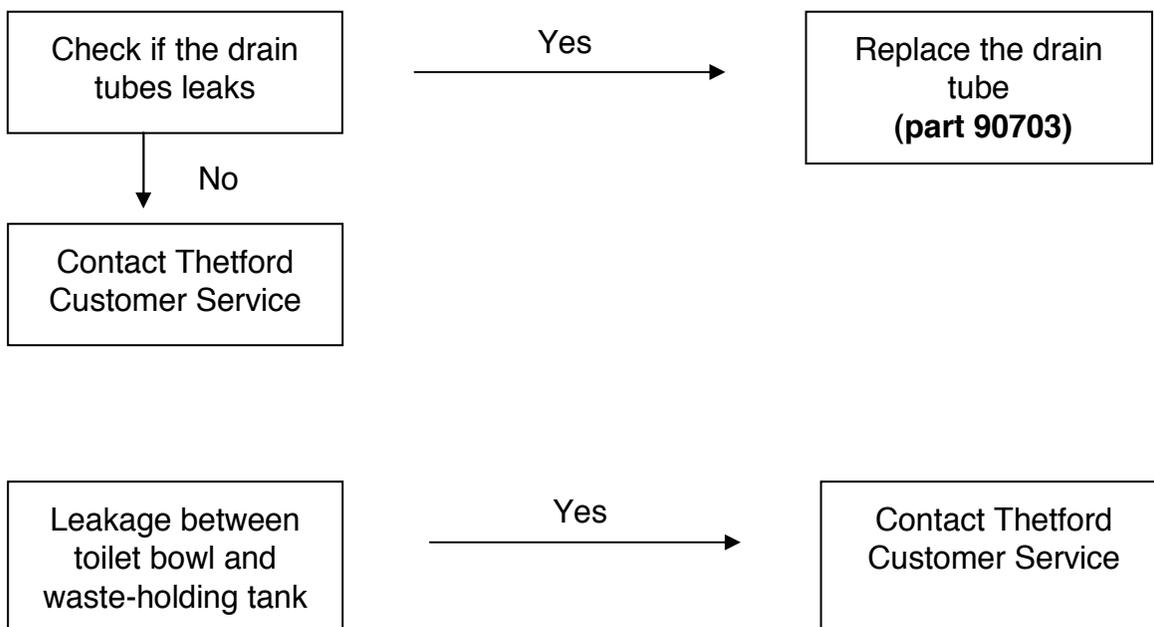
➤ Leakage at the Water tank

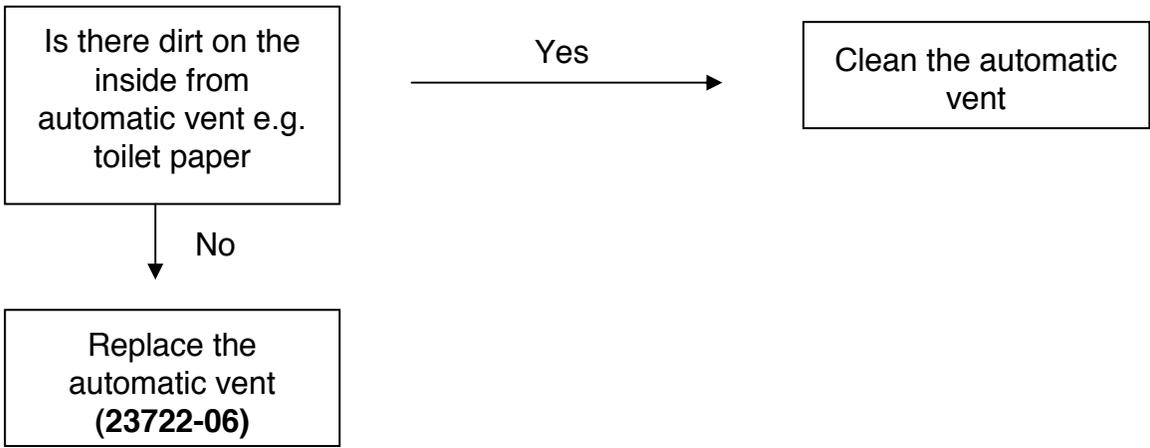
▪ **Leakage at the automatic vent**
